E-type DIY restoration project

The first in a series of articles by member **Mike Davison**, following the 10-year restoration of his 1970 S2 2+2

The second in a series of articles by member **Mike Davison**, detailing the 10-year restoration of his 1970 S2 2+2

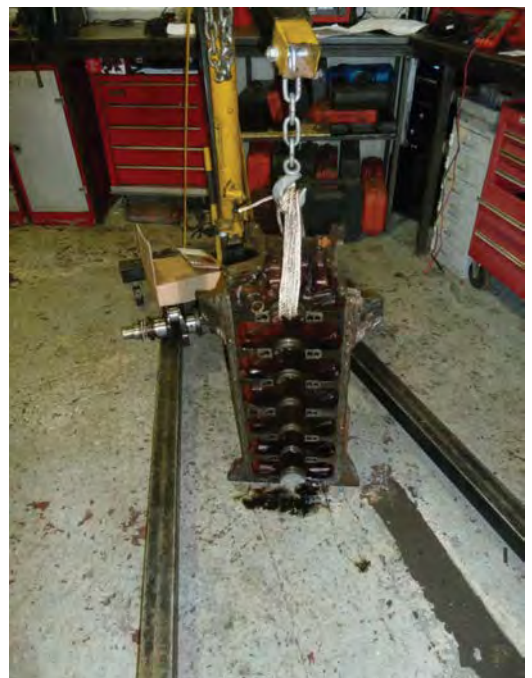
The block had now been completely dismantled, which had unfortunately shown the bores to be not quite as good as first thought, as some degradation to the surface of the bores was evident. The pistons had been removed, which revealed a number of the rings to be broken and others to be seized in the piston grooves. The crank main and big-end bearings were also suspect. Both the block and crank were sent to a machine shop to await diagnosis. New timing chains, chain guides and dampers were purchased as a matter of course, and a new timing-chain idler sprocket bush was fitted, since it was suspect. Main and big-end bearings would be obtained once the machine shop confirmed the correct crank regrind sizes.

- Top: Mike's splendid E-type sits proudly on his drive at the conclusion of its restoration
- Above: inspection of the block revealed the bores to be in poor condition, and so the block was sent to a machine shop for diagnosis

On detailed inspection of the block, it was evident some of the cylinder liners had dropped. There was also doubt whether, if rebored, they would move again during the machining process. As with the pistons, there were various options, including flanged liners which necessitate the tops of cylinders to be machined to accept the flange on the liner. This method prevents the liner from dropping. What material spec for the liner? The vast majority of liners are made from centrifugal-spun cast-iron, or spun ductile cast-iron, the latter being superior and typically used for race engines. It was considered the best solution in our case would be to replace the liners with non-flanged standard, centrifugal-spun cast-iron items.

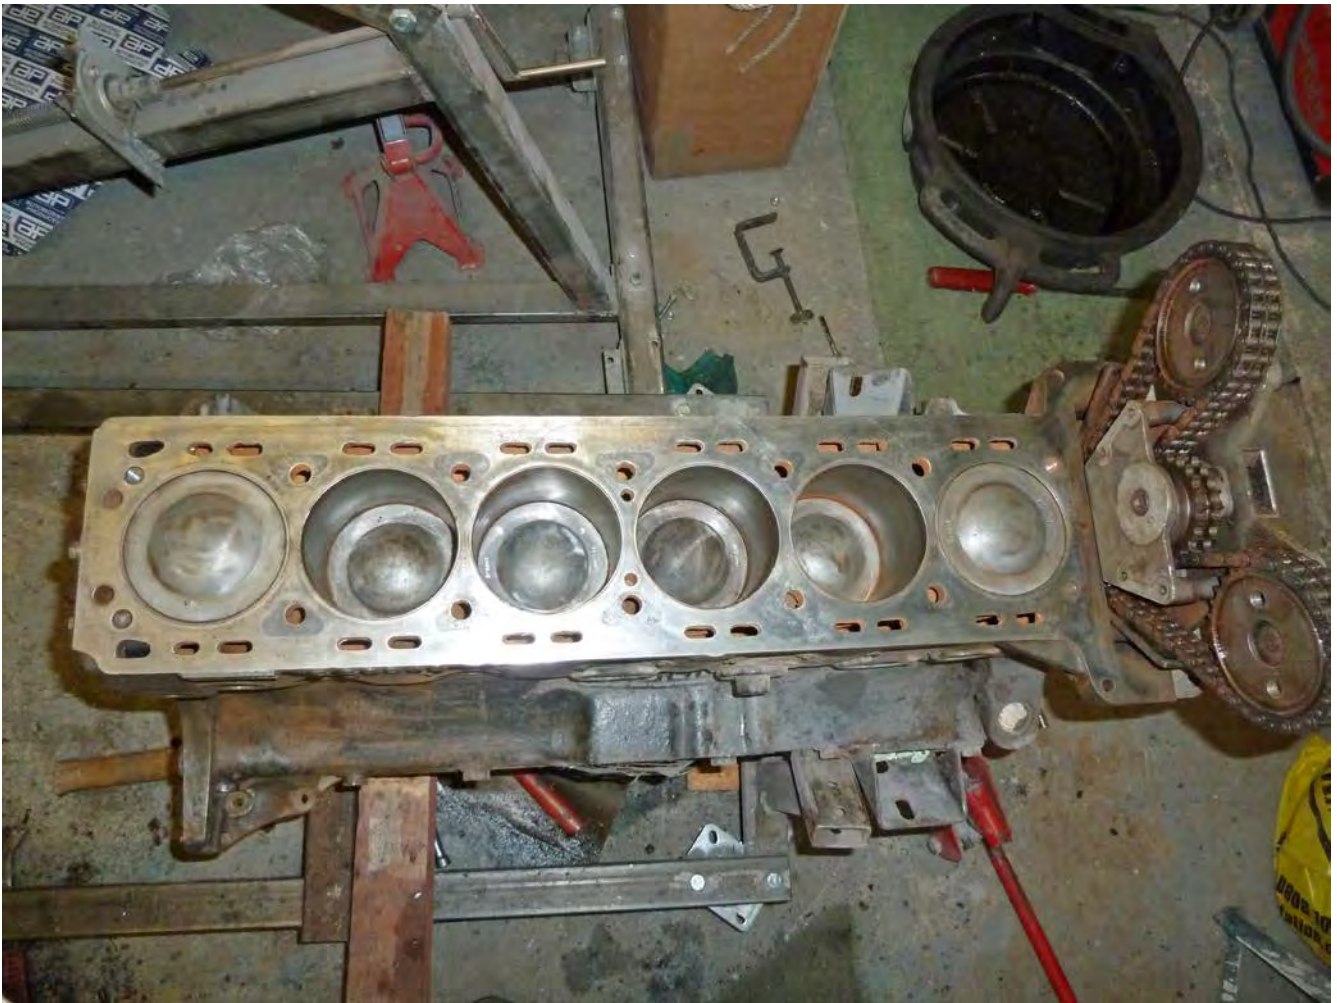
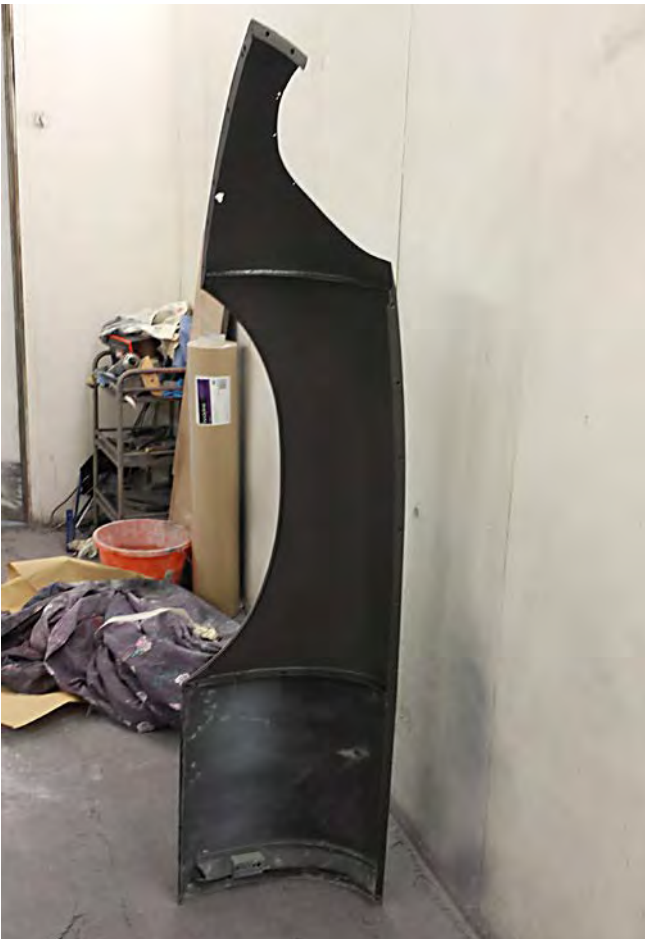
- Above: removal of the pistons revealed several broken rings. Eventually, new cast-iron cylinder liners (with standard bore size) were fitted, along with the original cleaned-up pistons and new rings.
- Left: a mixture of new and 'old' parts was used to rebuild the bonnet. The offside wing is seen here, but the nearside wing proved a challenge to align!

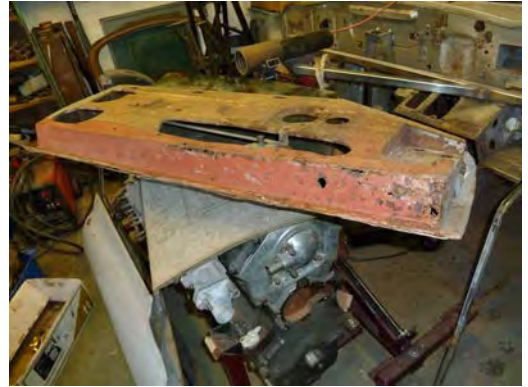
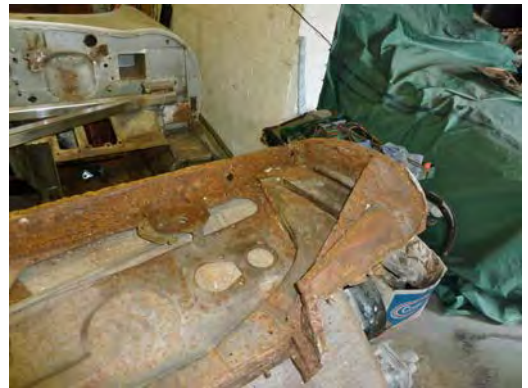
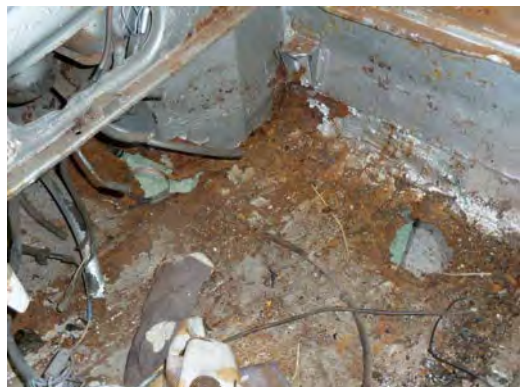
- Right, clockwise from top left: the poor condition of the boot floor can clearly be seen; the left-hand door showed signs of corrosion and previous repairs; the right-hand door frame was also badly corroded; with the fuel tank removed, the poor condition of the left-hand-side boot floor was revealed; the right-hand rear wheel arch with the sill removed, exposing more damage; the left-hand rear suspension would need attention and once again corrosion had taken hold; stripping of the left-hand door revealed more corrosion in the frame

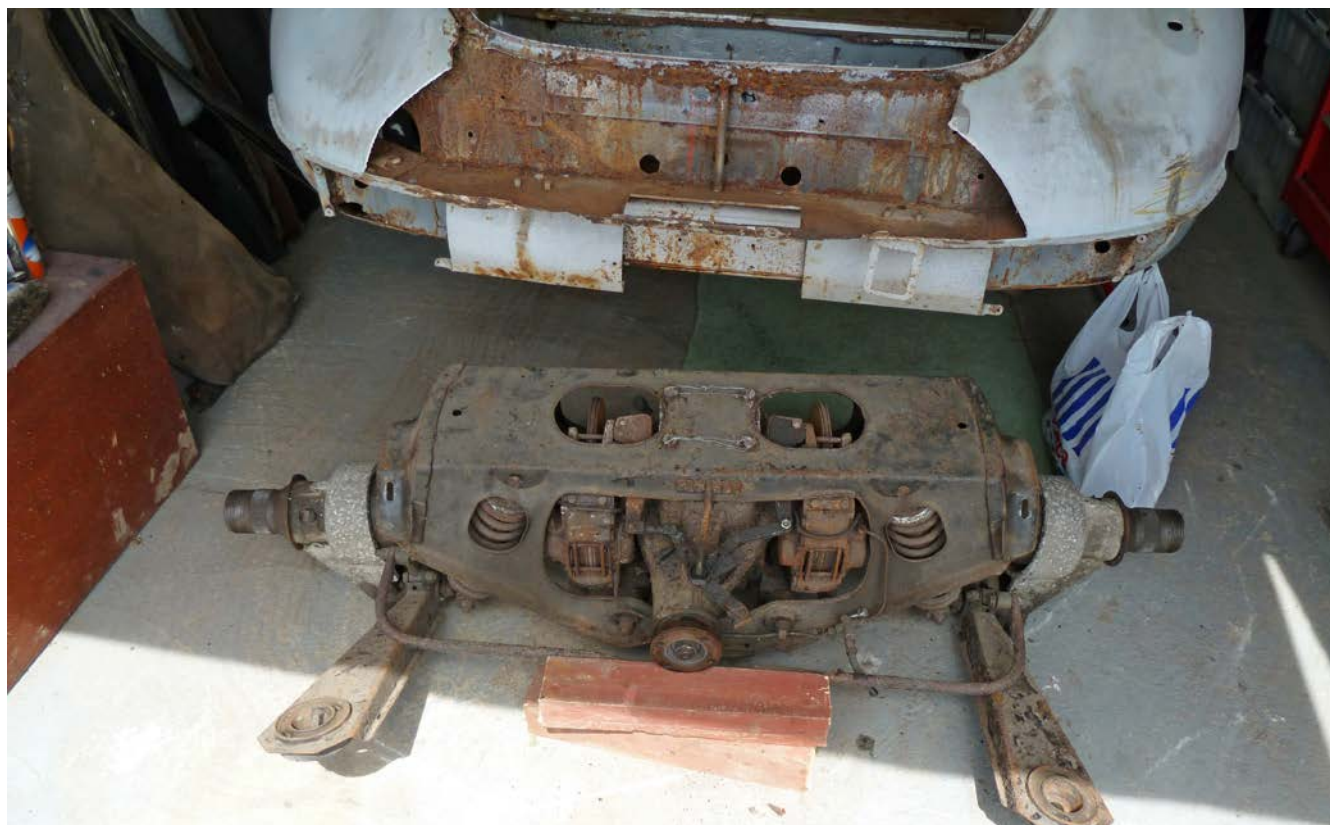
- Above: the rear subframe assembly removed, ready to start work on the rear diff, suspension and brakes. With the rear tonneau panel removed from the body, internal corrosion due to a blocked drip tube can be seen

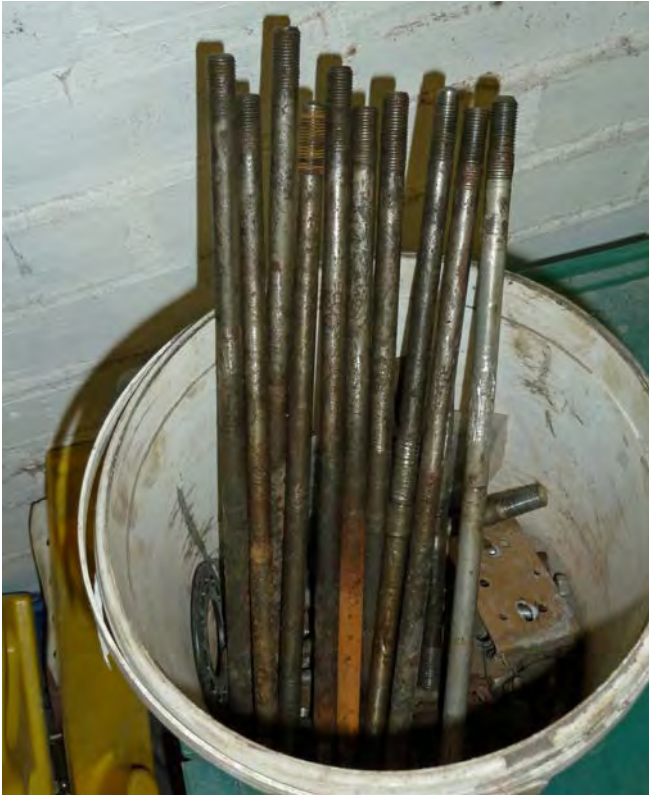
The cylinder head was removed, and considering how long the car had stood, both the combustion chambers and the bores appeared to be in good condition. For the uninitiated, there are 14 head studs, comprising four different types, with 10 of them partly exposed to the cooling water within the block itself, which can lead to degradation to the surface of the studs over a period of time. For peace of mind, since some of the studs showed signs of deterioration, we decided to replace them.

- Above: the newly skimmed friction surface of the flywheel
- Right: removal of the cylinder head to inspect the block showed the cylinder bores to be in good condition

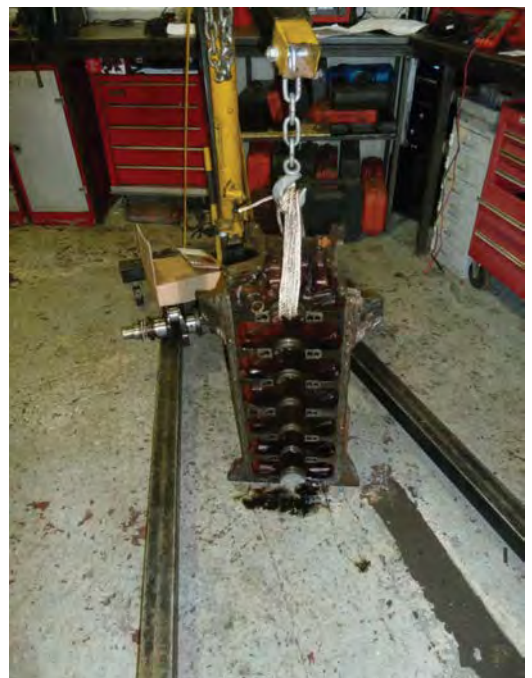
The block had now been completely dismantled, which had unfortunately shown the bores to be not quite as good as first thought, as some degradation to the surface of the bores was evident. The pistons had been removed, which revealed a number of the rings to be broken and others to be seized in the piston grooves. The crank main and big-end bearings were also suspect. Both the block and crank were sent to a machine shop to await diagnosis. New timing chains, chain guides and dampers were purchased as a matter of course, and a new timing-chain idler sprocket bush was fitted, since it was suspect. Main and big-end bearings would be obtained once the machine shop confirmed the correct crank regrind sizes.

- Top: Mike's splendid E-type sits proudly on his drive at the conclusion of its restoration
- Above: inspection of the block revealed the bores to be in poor condition, and so the block was sent to a machine shop for diagnosis

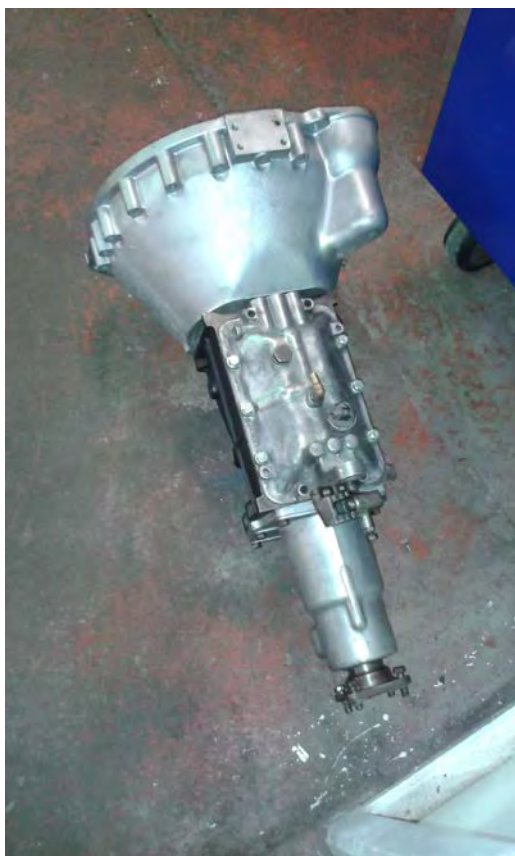
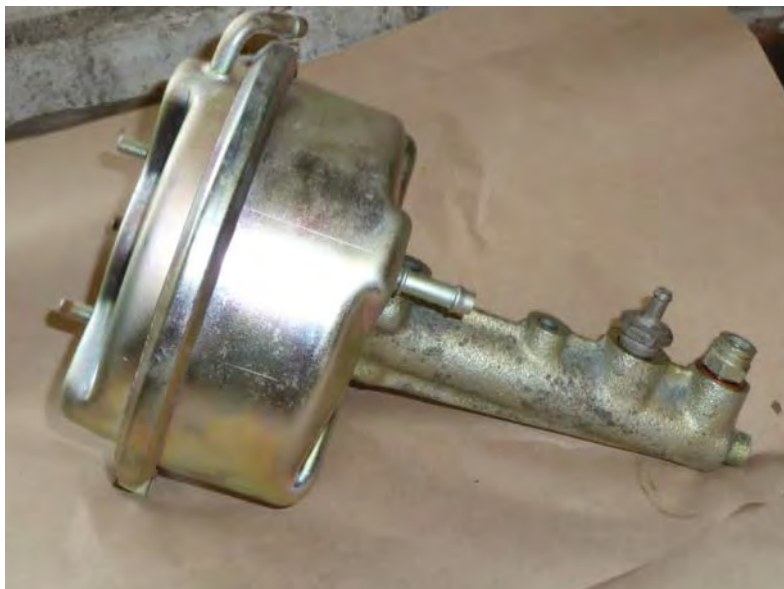
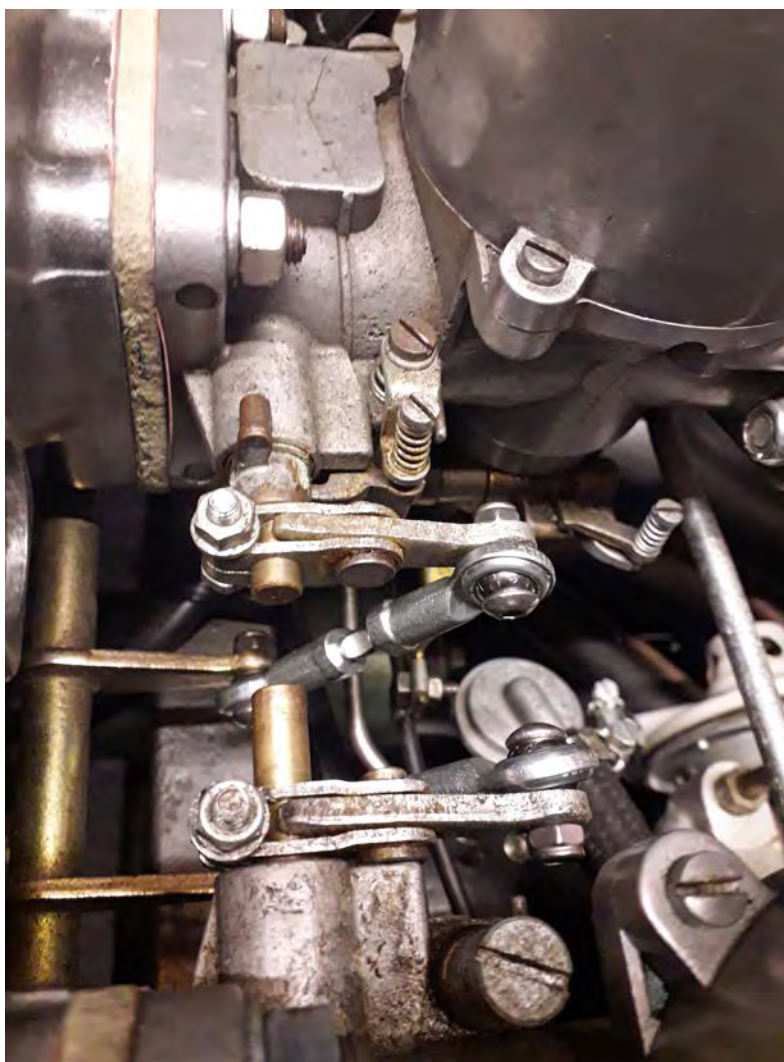
The brake master cylinder and reaction valve had also been dismantled, and a service kit purchased. At this point, closer inspection of the master-cylinder piston bore indicated it was actually beyond being serviceable. Rather than purchasing a

complete new master cylinder, I decided to buy an exchange core unit – ie, a master cylinder that had been sleeved to provide a new piston bore. I went for a brass sleeve, but stainless-steel sleeves are also available.

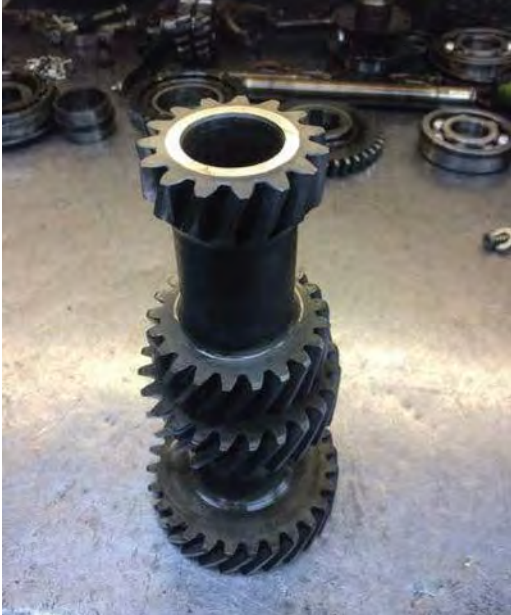
- Left: the gearbox was stripped for inspection by a specialist, revealing damage to the layshaft and laygear
- Below left: the damaged laygear-shaft bearing surface proved a tricky problem to solve due to the availability of new components
- Below right: a decision was taken to hard-metal sleeve the laygear to solve the problem of the damaged bearing surfaces
- Bottom: a new clutch-release bearing was fitted before the rebuilt gearbox was mated to the engine

With the benefit of hindsight, the gearbox should probably have been sent to the specialist for strip-down and inspection earlier in the restoration process. I had previously taken off the top cover plate when trying to free up the selector rods, and on the face of it the gears looked fine. As with a lot of other things, as restoration progressed all was not what it seemed! The strip-down revealed everything to be in serviceable condition with the exception of the layshaft and laygear. In both cases, the respective needle-roller-bearing surfaces had picked up. This was likely due to wear and tear, and as a result of the gearbox shafts not having been turned over due to being idle for 30-plus years. I had thought it may have been the main bearing ball-races that would cause problems, but no, they were in order. Replacing the whole gearbox was not considered practical for cost reasons, so other options had to be investigated. Firstly, what to do with the layshaft and needle rollers. Fortunately, both these components are readily available as spares, and can be replaced with new parts either from a recognised classic spares stockist or a specialist Jaguar motorsport company. The laygear, however, is a different matter. Obtaining the laygear as a new individual part is nigh on impossible, primarily due to the small batch order quantities and slow stock turnover. It would normally have been sold as part of a kit, ie, as a set with its mating gears, as it is not recommended to replace a single gear on its own. It is possible to have a gear reverse-engineered, but again costs are prohibitive.

ball-races to deteriorate over time when not used regularly, it was decided to send the gearbox to a local specialist for a complete strip-down, inspection and to have new parts fitted where necessary.

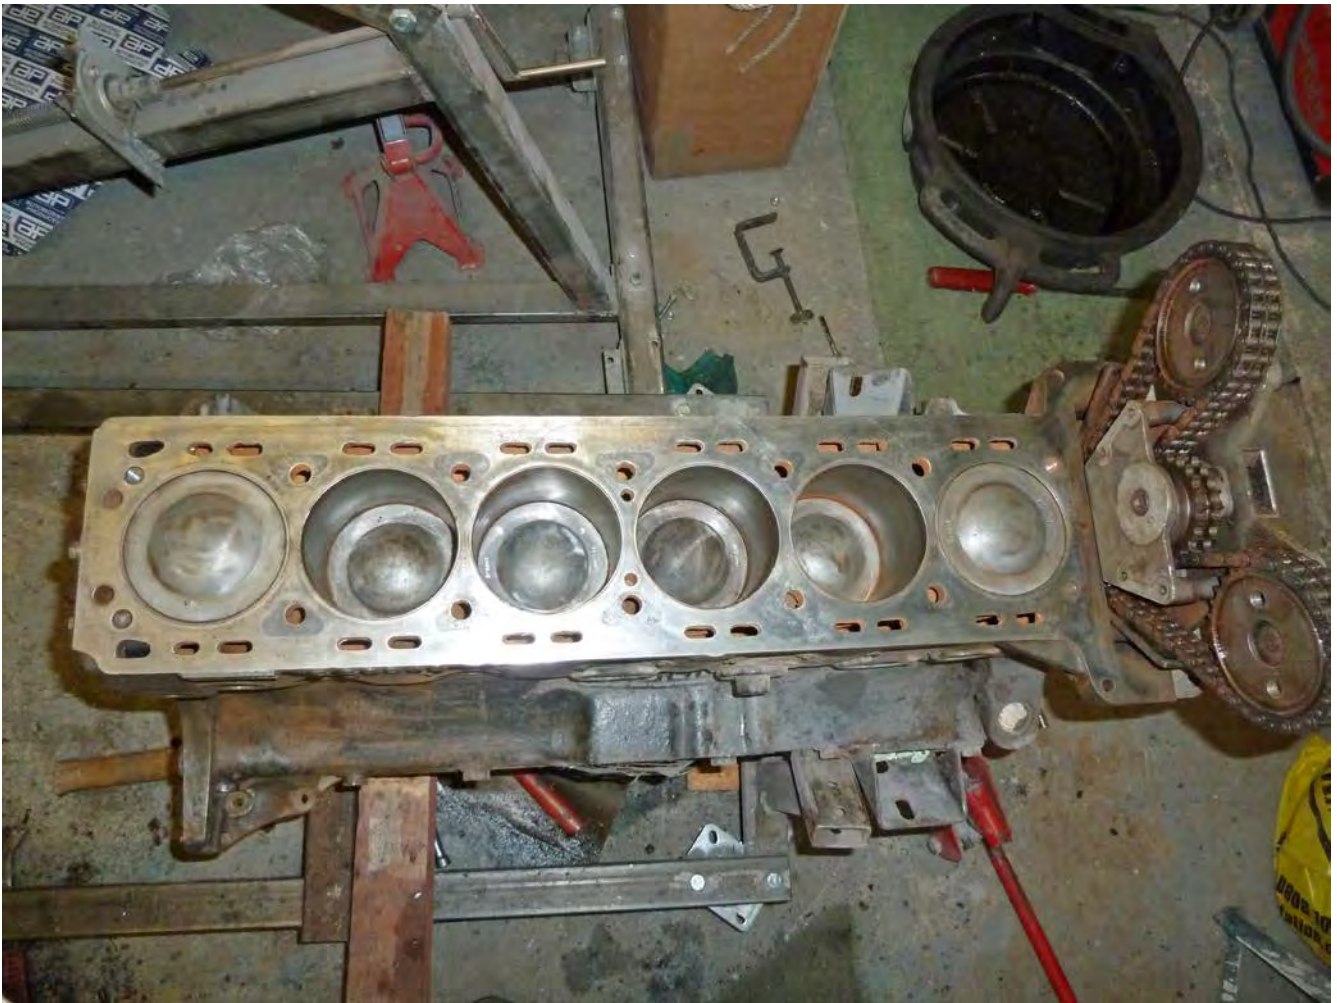
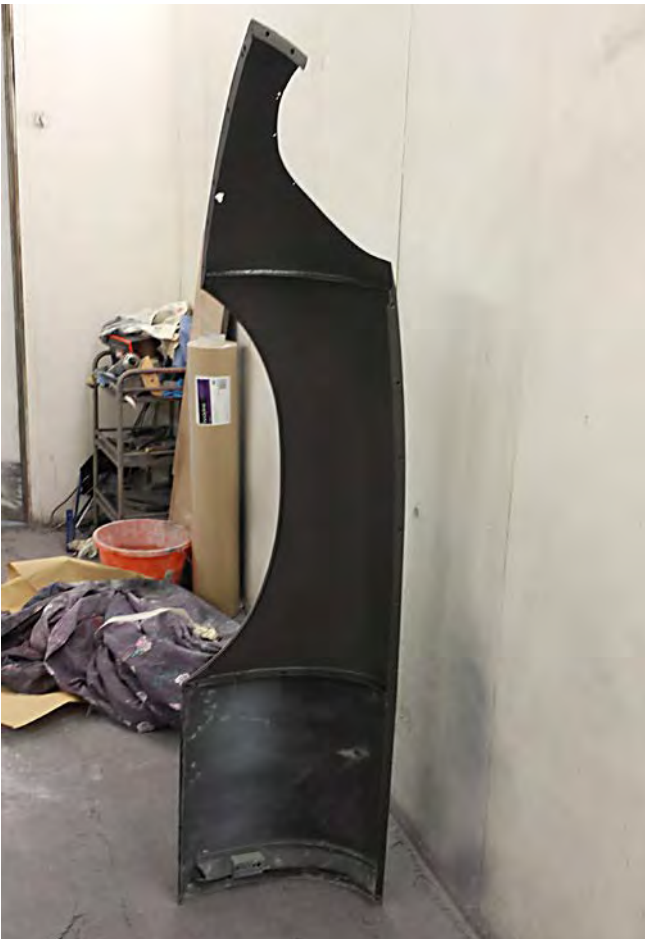
- Above: removal of the pistons revealed several broken rings. Eventually, new cast-iron cylinder liners (with standard bore size) were fitted, along with the original cleaned-up pistons and new rings.
- Left: a mixture of new and 'old' parts was used to rebuild the bonnet. The offside wing is seen here, but the nearside wing proved a challenge to align!
