# South African restoration

**Don Steenkamp** details the restoration of his Series II OTS and its conversion from US spec to UK/European spec to suit South African requirements

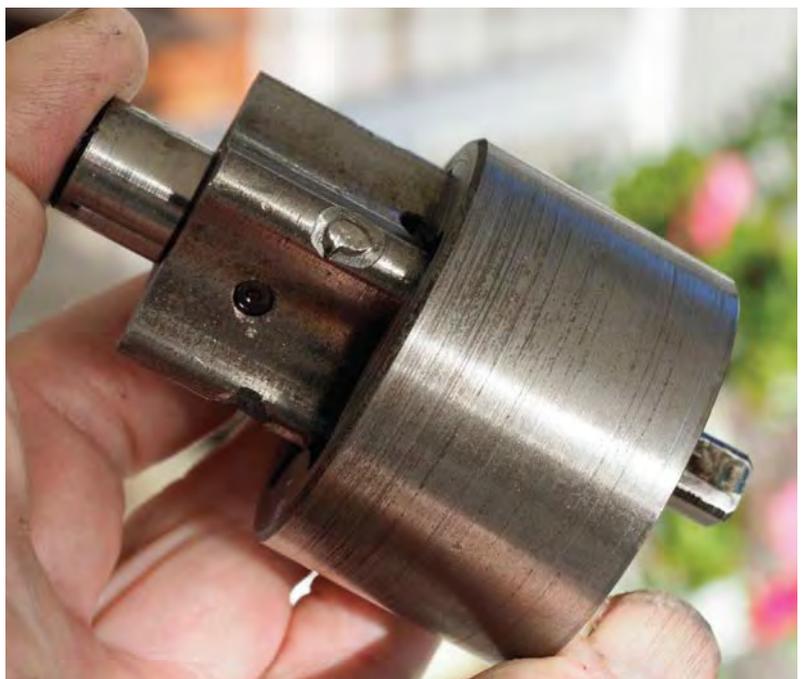
- Top: Don's E-type was originally Primrose Yellow, seen here in unrestored form outside his Knysna home in South Africa after shipping from Florida
- Above: on stripping the engine, an errant piece of metal – possibly a split washer – was found embedded in the oil pump rotor

The engine, although running when the car arrived, proved to have been put together by ‘bush mechanics’ (tighten bolt until it strips, then a quarter turn back!). The play on the crankshaft damper was excessive, and I rightly suspected the thrust bearings to be missing, confirmed when the sump was removed and the offending items were found in the sludge inside the sump. More alarming was the state of the oil pump, which had picked up what appeared to be a piece of metal – perhaps a split washer – which embedded itself inside the rotor assembly of the oil pump.

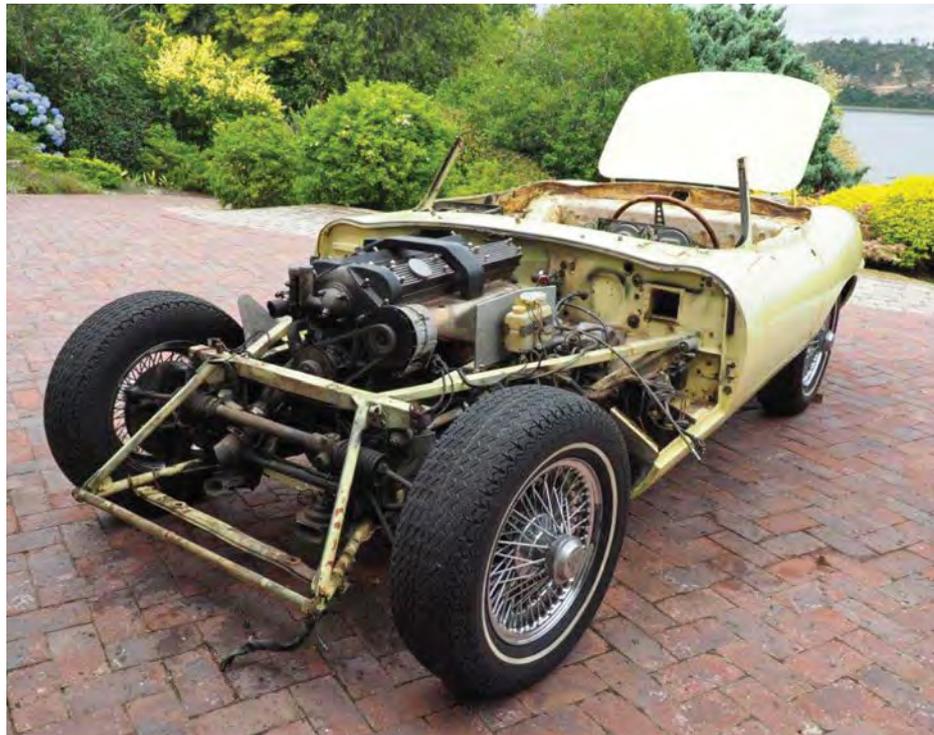
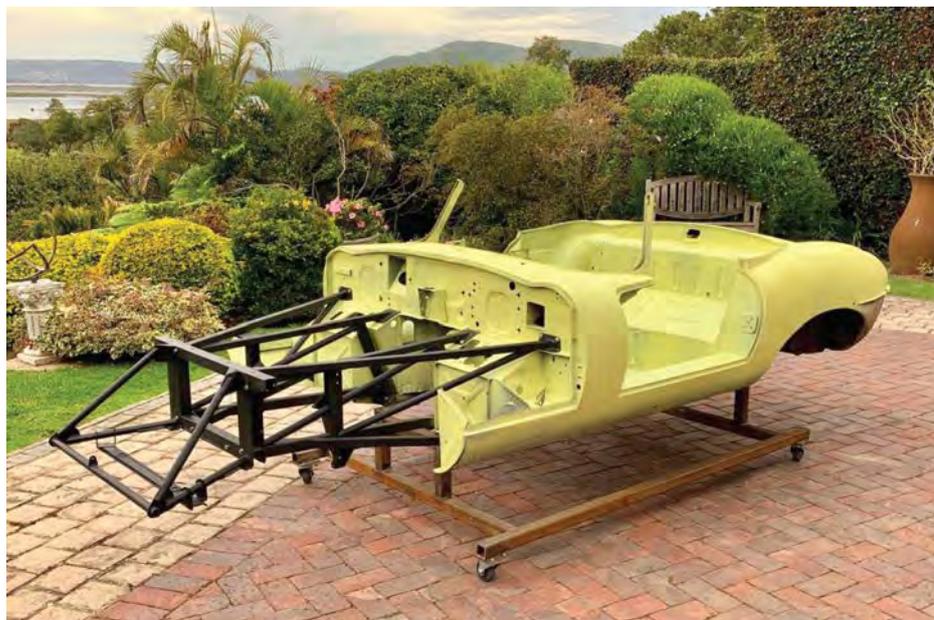
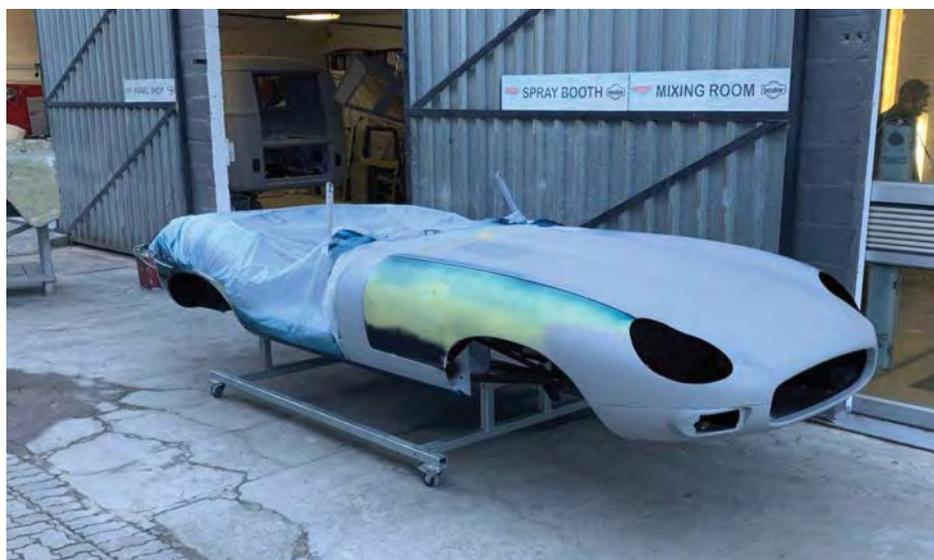
- Right: many hours were spent stripping the car, carefully documenting the location of every component
- Below right: new spaceframes were fitted to the original bodyshell which required new floor pans
- Bottom right: the restored body panels masked and primed before receiving the new Midnight Blue finish

The state of the bodyshell was better than expected, with only the two recessed floor pans needing to be replaced. The spaceframes were reasonable, apart from the bonnet support frame, which was badly distorted due to the car having been incorrectly jacked below the radiator crossmember. As the spaceframes were 50 years old, I chose to replace them with new frames supplied by E-type Fabs, who were an absolute pleasure to deal with. These frames were expensive, but the quality is superb!

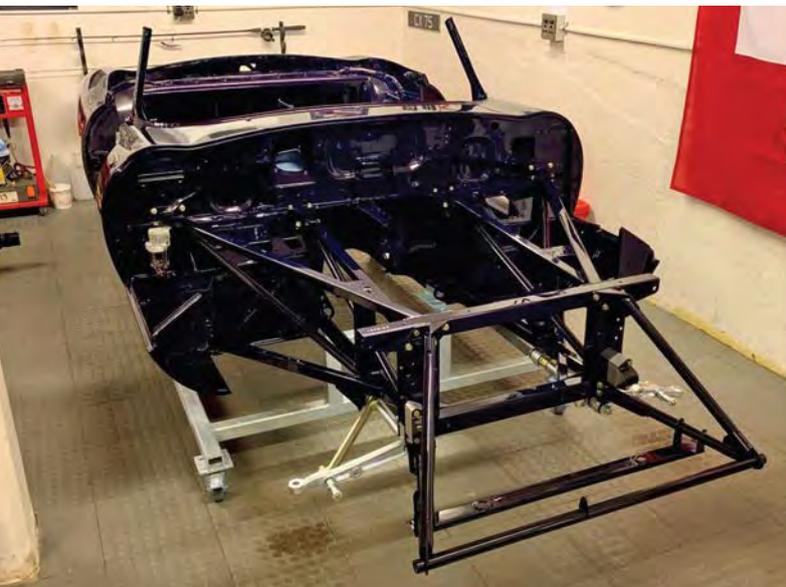
- Left: the newly sprayed bodyshell and spaceframes in the workshop at the start of the rebuild process
- Below left: the rebuilding and upgrading process underway, with front suspension and braking system components fitted
- Below: new rear ventilated disc brakes and Koni Classic suspension dampers were among the upgrades

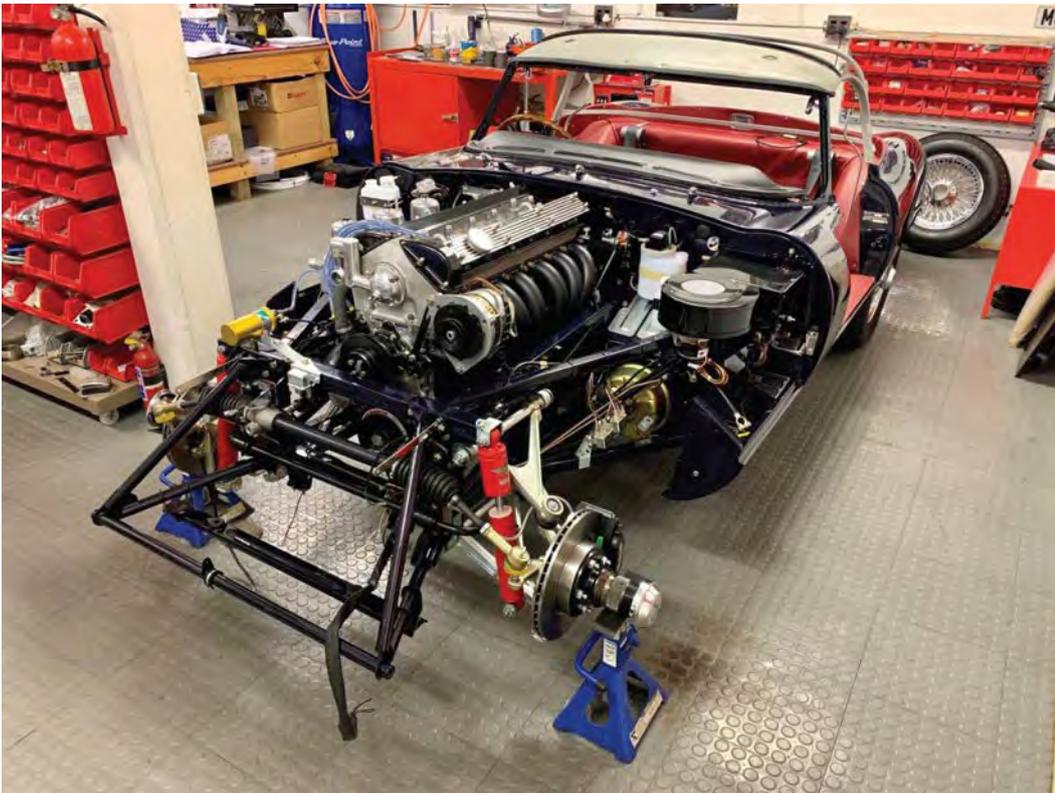
- Left: the rebuild continues, with steering components plus engine and ancillaries now in place
- Below left: engine upgrades included a stainless-steel big-bore exhaust system and silicone plug leads
- Below: a triple HD8 SU carburettor conversion and Classic Sports Ignition electronic distributor were among other sensible upgrades that Don elected to make

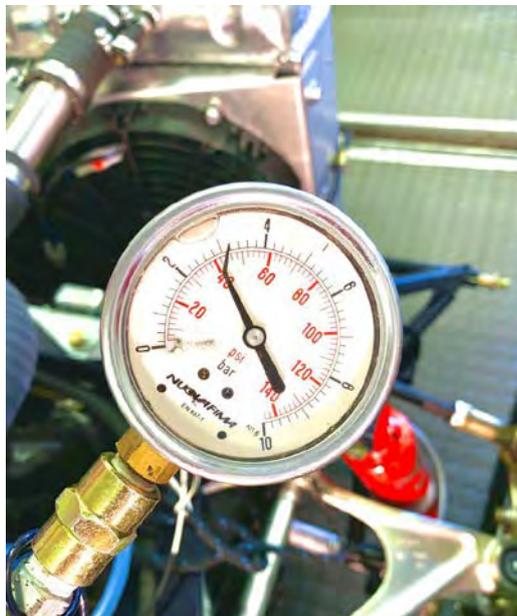
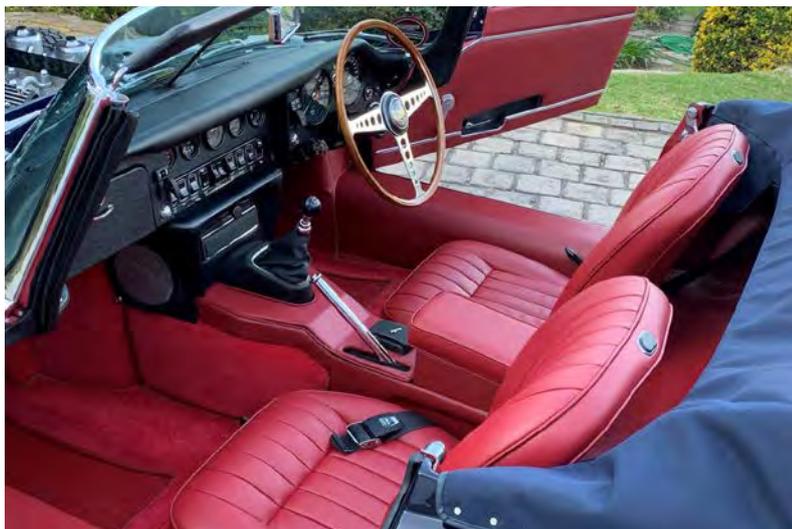
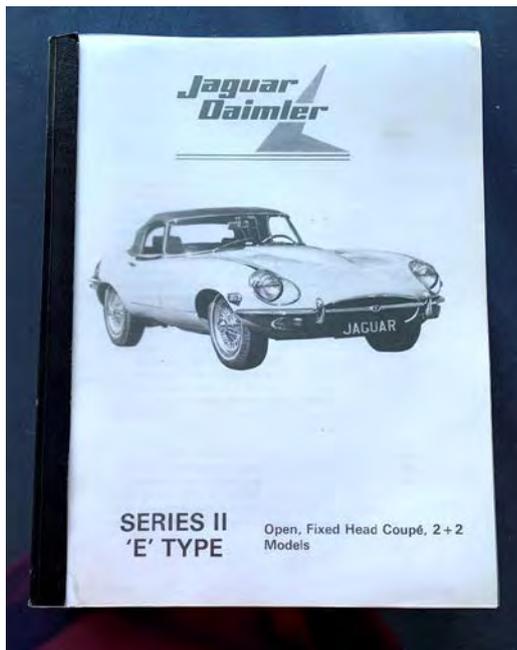
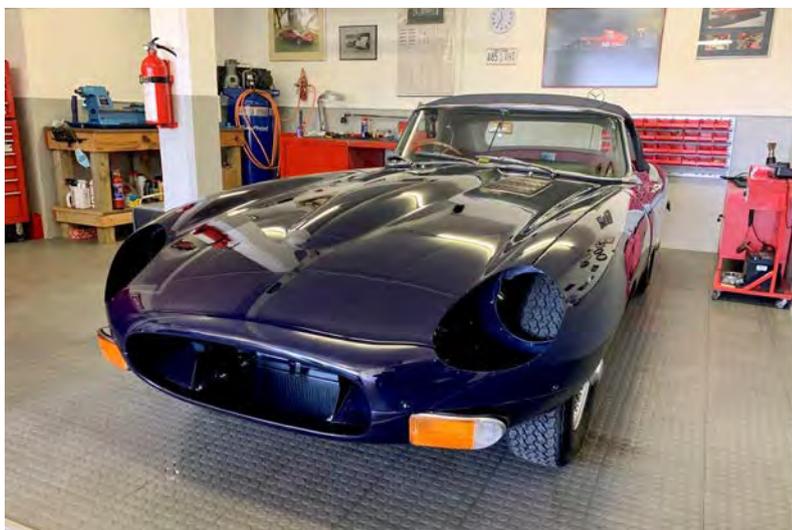
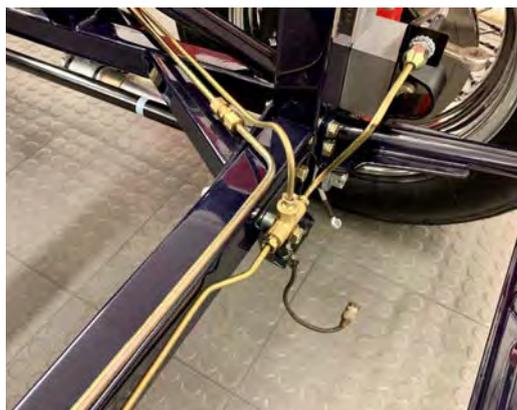
- Below left and bottom left: the new Dark Red interior perfectly complements the Midnight Blue exterior
- Below: gauge connected to check oil pressure before firing up the rebuilt engine for the first time
- Below middle: this US-sourced unofficial Spare Parts Manual for the SII proved invaluable
- Bottom: new brake lines made from Bundy tubing

I prefer to make up my brake lines from the correct 3/16in and 1/4in Bundy tubing, using a professional Sykes Pickavant flaring-tool kit. In this regard, it is important to remember to double-flare certain sections, eg, the original three-way union attached to the lower picture frame which requires a double flare on all three unions.

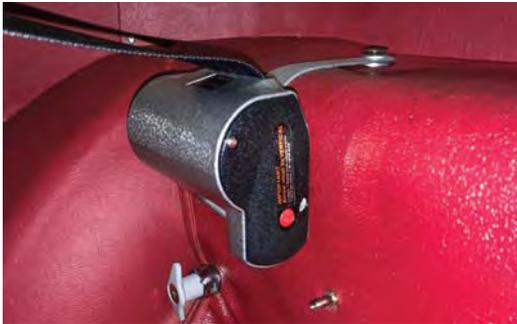
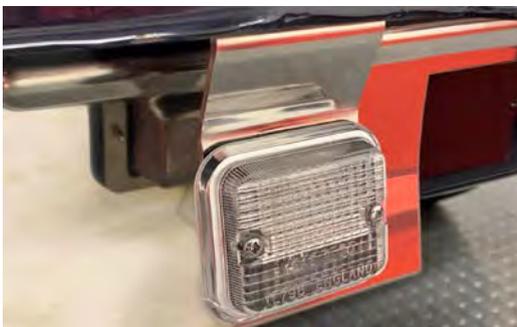
- Below: new Kangol inertia-reel seatbelts were modified from Land Rover Defender items
- Bottom: laser-cut stainless-steel reversing-lamp bracket
- Right: setting up the front suspension prior to the first test drive
- Bottom right: The finished restored and upgraded S11 Roadster in all its glory, after over 3,000 hours of Don's time

The last of the Series II Roadsters, as with the Series 3 cars, were fitted with Kangol Reflex inertia-reel seat belts. My car had these fitted, but they were in a poor condition; the belts very dirty and frayed, the mechanism not retracting, and the hardware badly rusted. An internet search found little available, but Blanchard & Co, in the UK, advertised new classic Kangol Reflex belts for Land Rover Defenders, which I ordered at a rather expensive price for a set of two. The Kangol units are identical to the those originally fitted to my E-type, but the new belts were far too long. I used my old belts to calculate the length required, and I then cut the new belts to the same length. I had new buckle hardware laser-cut in stainless steel, and used an industrial sewing machine to restitch the hardware to the belts using exact correct criss/cross stitching pattern. Once the 'Jaguar Lift' decal was placed in position, the belts matched the originals in every way.

I had difficulty in sourcing the correct mounting brackets for the reversing lamps (part numbers differ for RHD), and I eventually made a drawing and had a set of brackets laser cut and bent using 316-grade stainless steel.
