E-type DIY restoration project

The first in a series of articles by member **Mike Davison**, following the 10-year restoration of his 1970 S2 2+2

The second in a series of articles by member **Mike Davison**, detailing the 10-year restoration of his 1970 S2 2+2

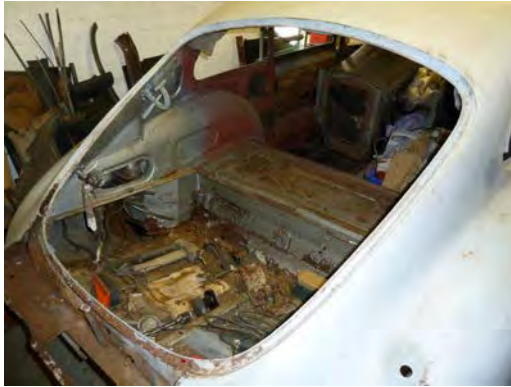
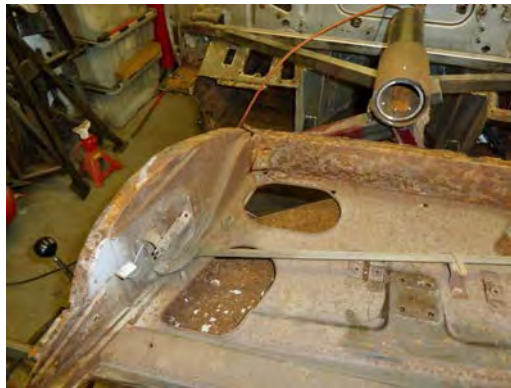
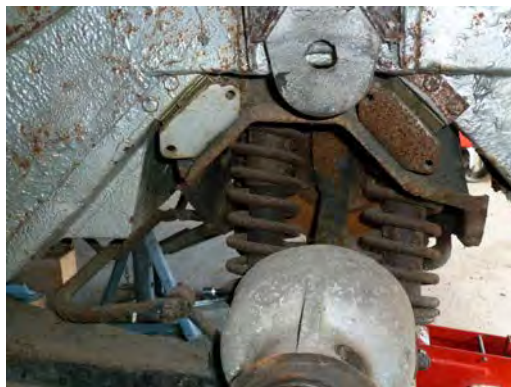
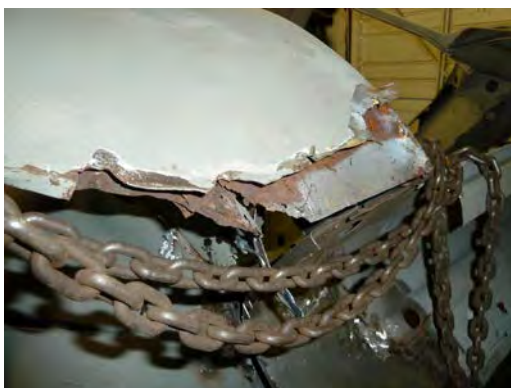
- Right, clockwise from top left: the poor condition of the boot floor can clearly be seen; the left-hand door showed signs of corrosion and previous repairs; the right-hand door frame was also badly corroded; with the fuel tank removed, the poor condition of the left-hand-side boot floor was revealed; the right-hand rear wheel arch with the sill removed, exposing more damage; the left-hand rear suspension would need attention and once again corrosion had taken hold; stripping of the left-hand door revealed more corrosion in the frame

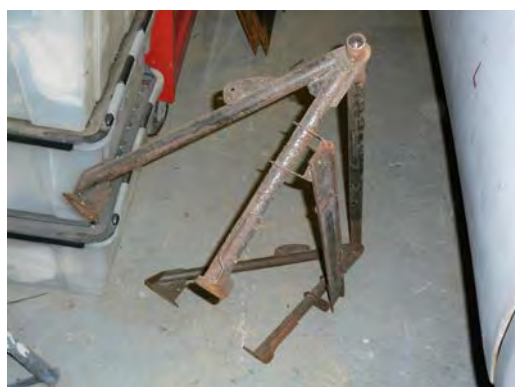
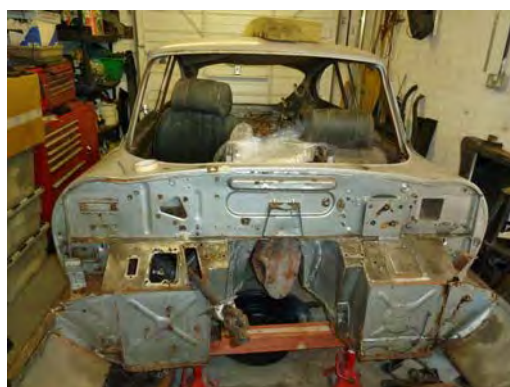
- Above: the rear subframe assembly removed, ready to start work on the rear diff, suspension and brakes. With the rear tonneau panel removed from the body, internal corrosion due to a blocked drip tube can be seen

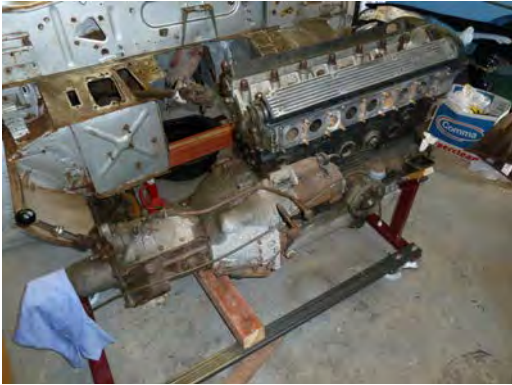
- Far left: the partially stripped body on a rotisserie prior to shot-blasting
- Left: trial fitting the bonnet, new wings and underpan in July 2014
- Middle far left: the engine and gearbox removed for attention
- Below: removal and inspection of the flywheel revealed scoring

- Above: the newly skimmed friction surface of the flywheel
- Right: removal of the cylinder head to inspect the block showed the cylinder bores to be in good condition

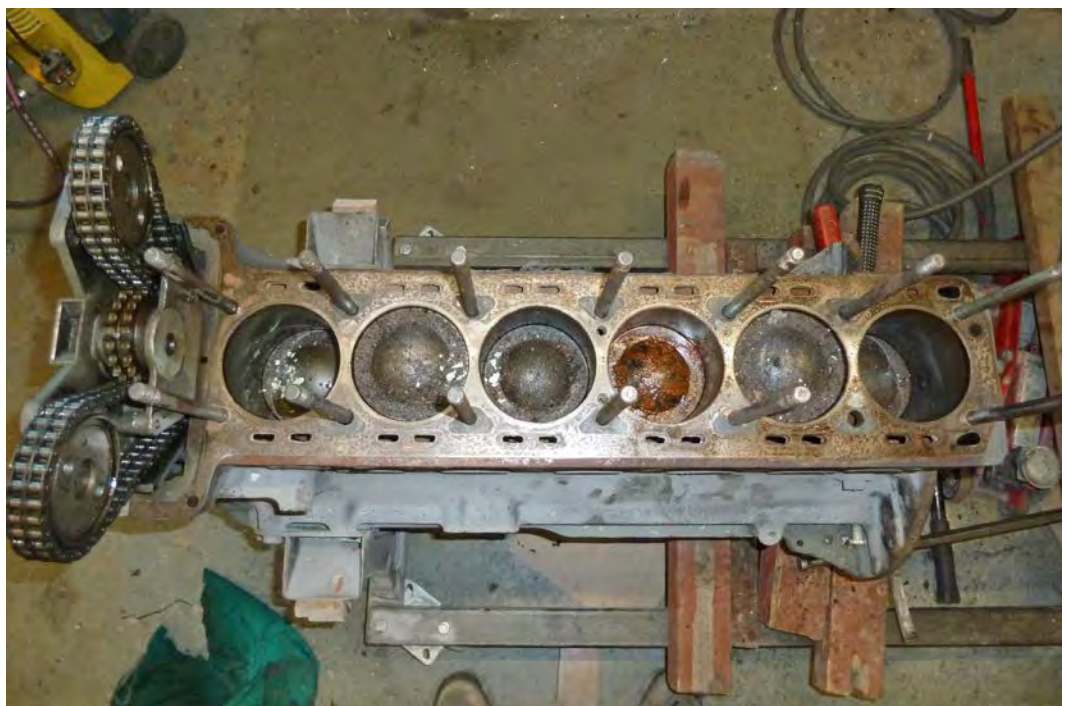
The cylinder head was removed, and considering how long the car had stood, both the combustion chambers and the bores appeared to be in good condition. For the uninitiated, there are 14 head studs, comprising four different types, with 10 of them partly exposed to the cooling water within the block itself, which can lead to degradation to the surface of the studs over a period of time. For peace of mind, since some of the studs showed signs of deterioration, we decided to replace them.

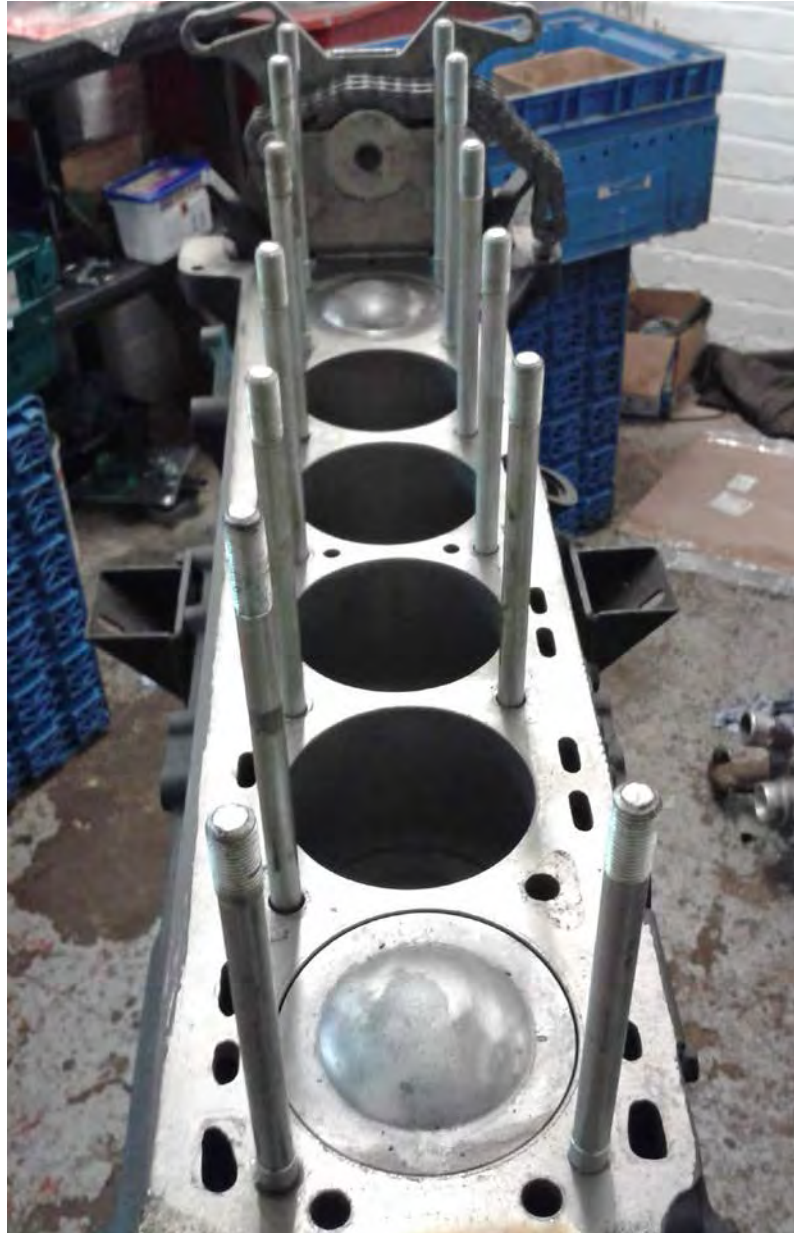
- Above: the old cylinder head studs were discarded
- Above right: the new studs in position in the rebuilt block
- Right: the cylinder head partly cleaned up after removal, prior to heading to the machine shop

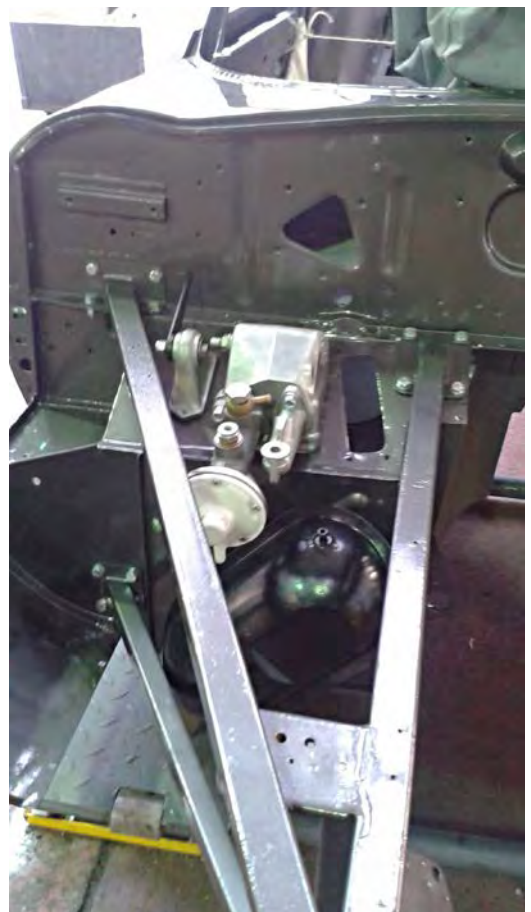
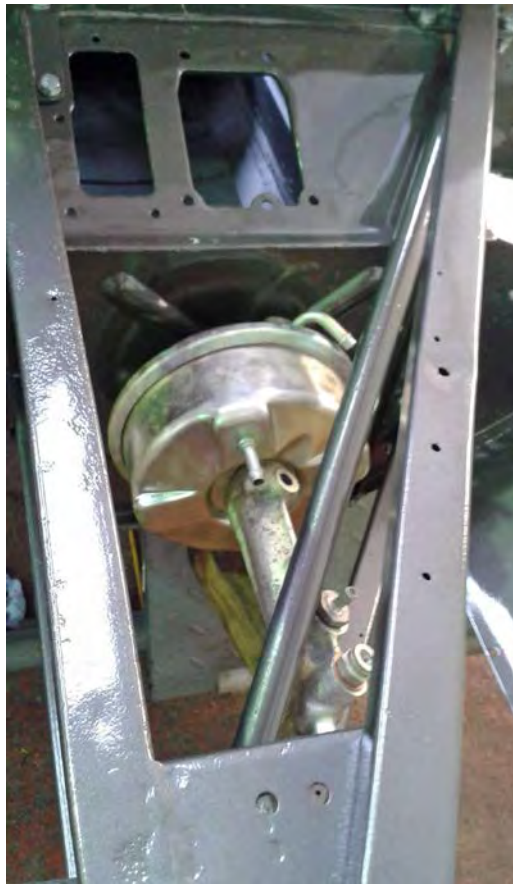
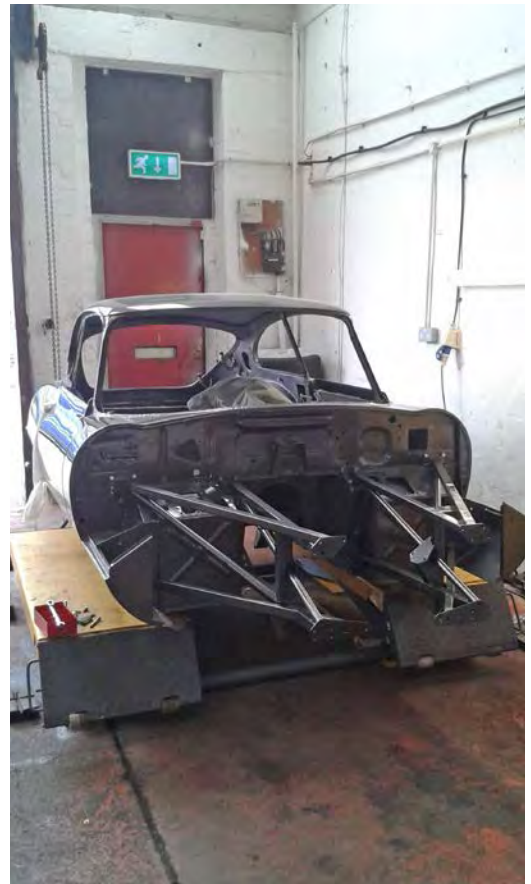
- Left: proving that all the hard work and effort was worthwhile, Mike's splendid E-type sits proudly on his drive at the conclusion of its restoration
- Below left: the brake vacuum cylinder...
- Right: ...and brake servo were trial-assembled before fitting the engine
- Far right: the front crossmember and bonnet support frame were left off until the engine and gearbox had been fitted
- Below: the engine and gearbox in place, with the front crossmember now in position
- Bottom: the front suspension and steering components fitted, with the bonnet support frame now attached to the crossmember

The brake-vacuum cylinder, together with the brake servo, clutch and brake pedal box, and accelerator pedal box were then fitted.

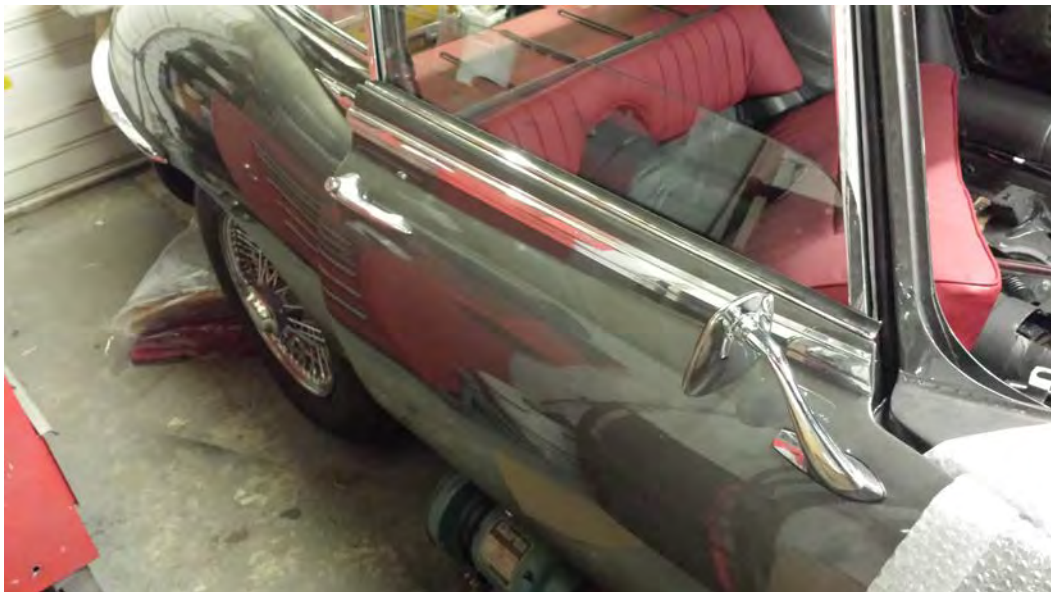
- Left: new wing mirror and door chrome in place – the door chromes proved tricky to fit
- Below: on the home stretch – the restoration enters its final phases

The door top chromes were also fitted. These were quite fiddly, as there are four rivet clips, as well as two screws holding each chrome. Accurate positioning of the holes for the rivets was a must! (Unfortunately, the new door skins were minus the holes.)

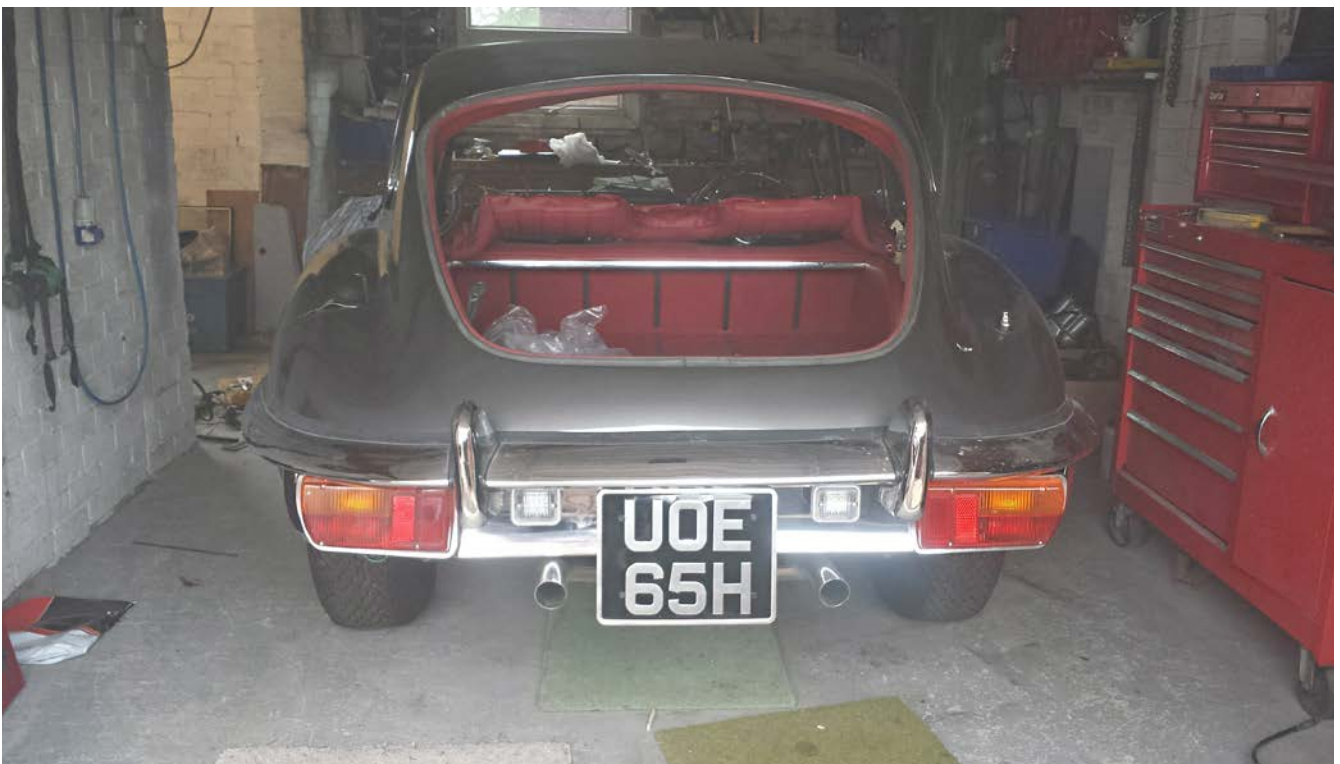
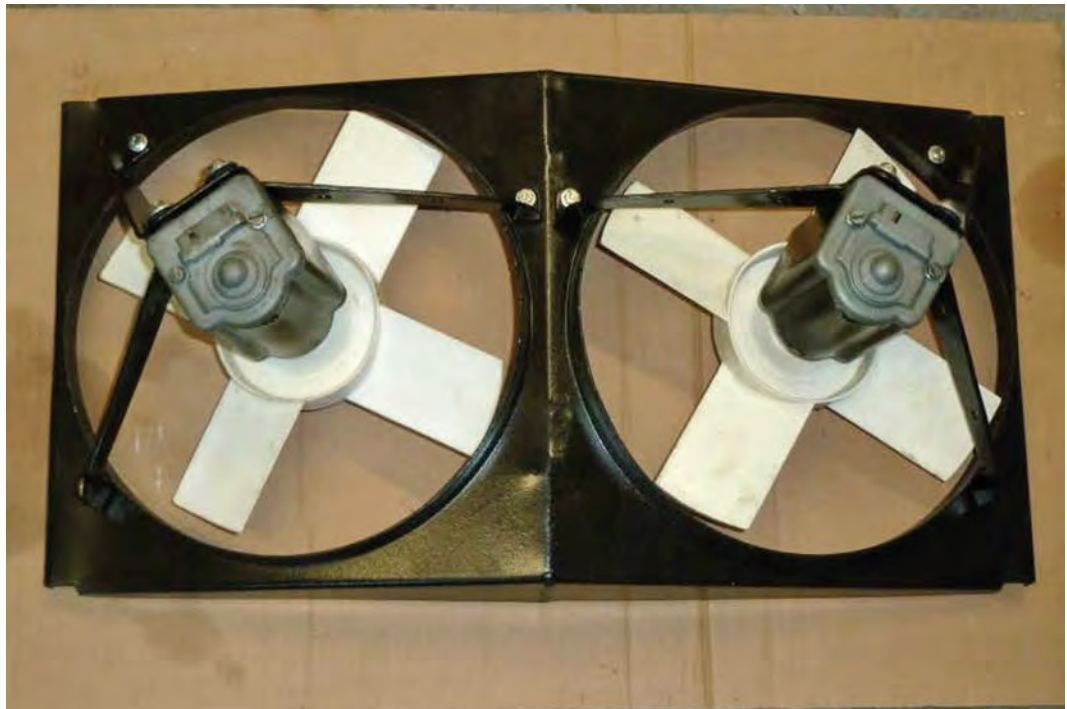
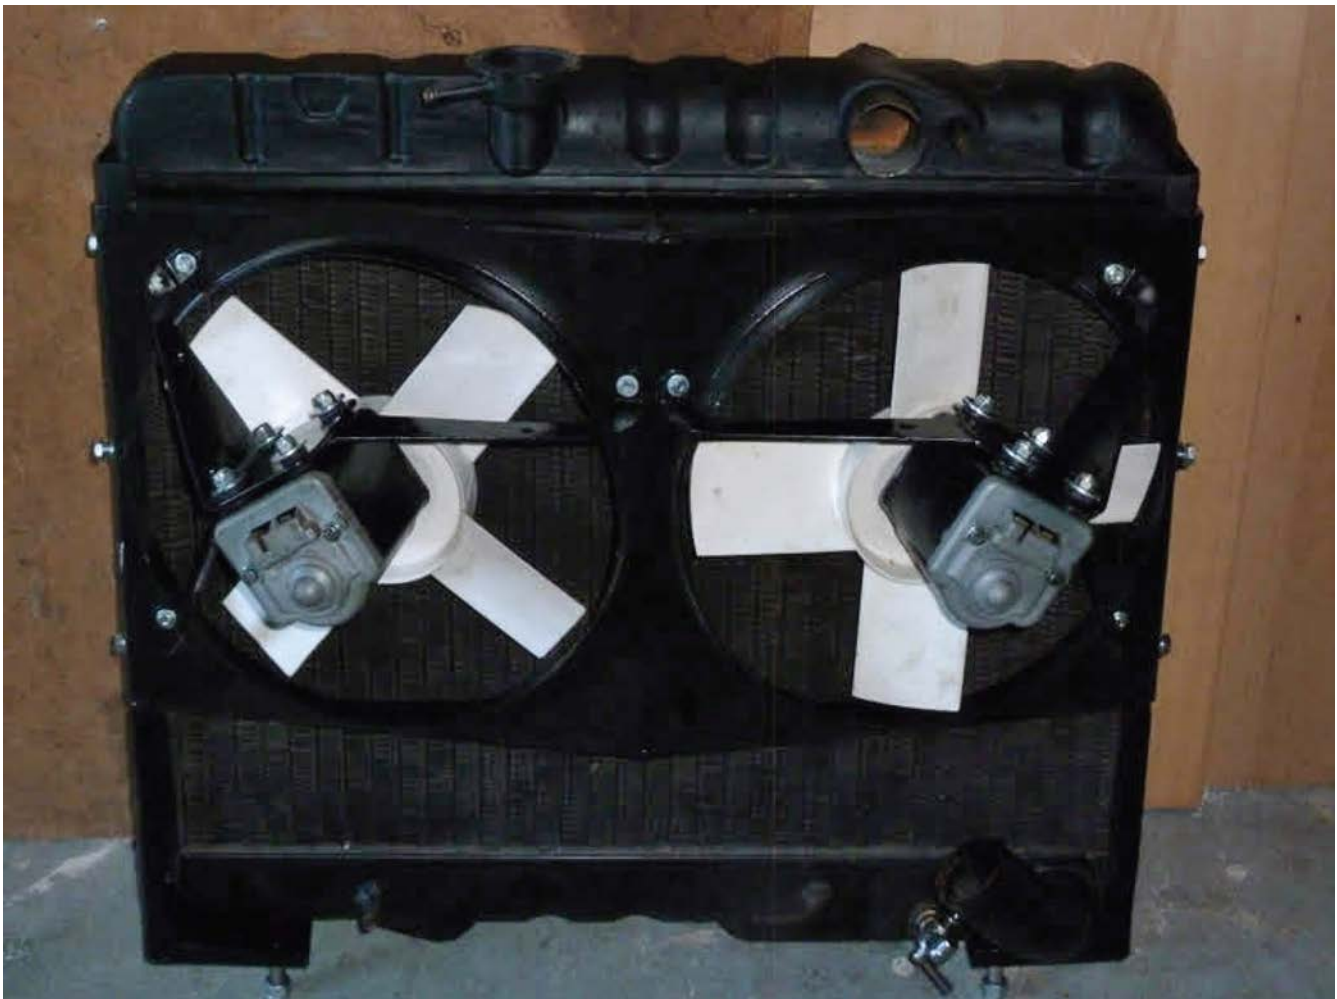
- Right: the cooling-fan motors were refurbished, new mounting rubbers were fitted and the mounting brackets were shot-blasted and powder-coated. One of the fan-blade assemblies supplied with the car was yellow, so was replaced with a new white assembly to provide a matching pair
- Below: The cooling-fan assemblies in place on the rear of the radiator

As fill-in jobs, reassembly of the cooling fan motors and fan cowl had been completed. These were stripped down and partly refurbished several years previously, and left as work in progress. One motor needed a new set of brushes and holders, and I managed to source these via eBay from a seller who specialises in reconditioning wiper motors and fan motors, amongst other things. Both motors needed new mounting rubbers, and the mounting brackets were shot-blasted and powder-coated. One fan-blade assembly was yellow, the other white, so another white assembly was sourced to provide a matching pair! Both motors were bench-tested and appeared to perform OK, despite them not having run for some 30 years.

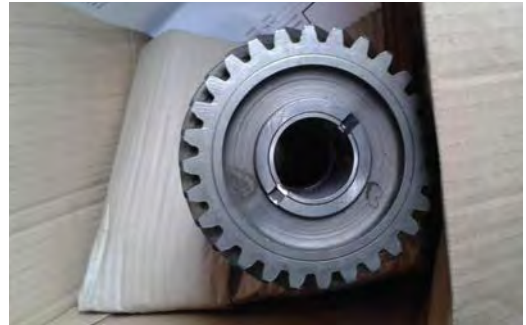
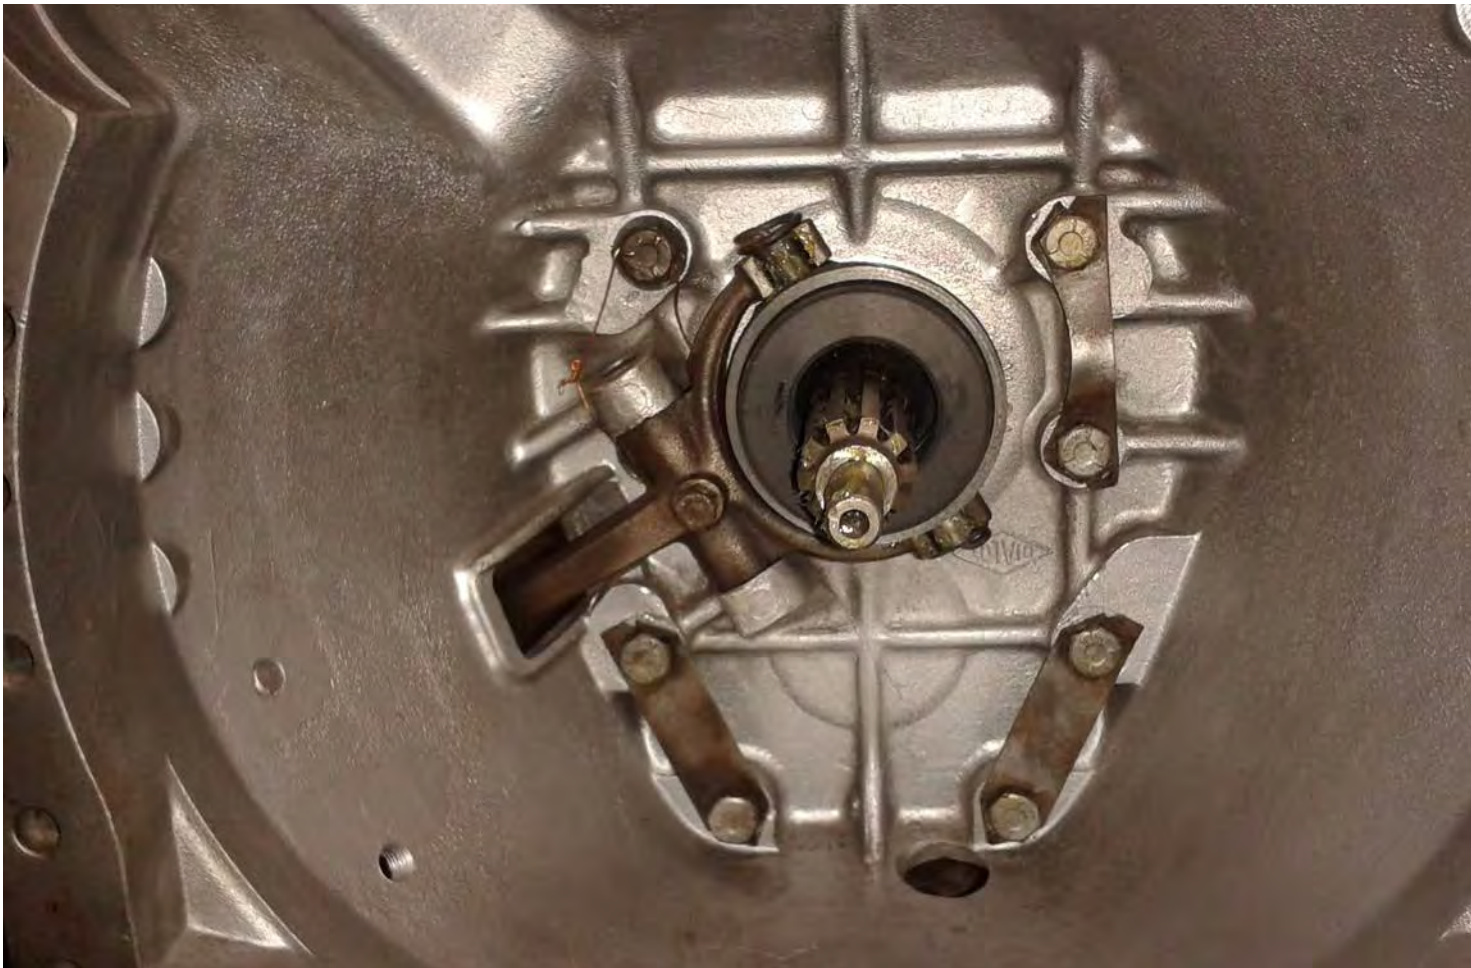
- Left: the gearbox was stripped for inspection by a specialist, revealing damage to the layshaft and laygear
- Below left: the damaged laygear-shaft bearing surface proved a tricky problem to solve due to the availability of new components
- Below right: a decision was taken to hard-metal sleeve the laygear to solve the problem of the damaged bearing surfaces
- Bottom: a new clutch-release bearing was fitted before the rebuilt gearbox was mated to the engine

With the benefit of hindsight, the gearbox should probably have been sent to the specialist for strip-down and inspection earlier in the restoration process. I had previously taken off the top cover plate when trying to free up the selector rods, and on the face of it the gears looked fine. As with a lot of other things, as restoration progressed all was not what it seemed! The strip-down revealed everything to be in serviceable condition with the exception of the layshaft and laygear. In both cases, the respective needle-roller-bearing surfaces had picked up. This was likely due to wear and tear, and as a result of the gearbox shafts not having been turned over due to being idle for 30-plus years. I had thought it may have been the main bearing ball-races that would cause problems, but no, they were in order. Replacing the whole gearbox was not considered practical for cost reasons, so other options had to be investigated. Firstly, what to do with the layshaft and needle rollers. Fortunately, both these components are readily available as spares, and can be replaced with new parts either from a recognised classic spares stockist or a specialist Jaguar motorsport company. The laygear, however, is a different matter. Obtaining the laygear as a new individual part is nigh on impossible, primarily due to the small batch order quantities and slow stock turnover. It would normally have been sold as part of a kit, ie, as a set with its mating gears, as it is not recommended to replace a single gear on its own. It is possible to have a gear reverse-engineered, but again costs are prohibitive.

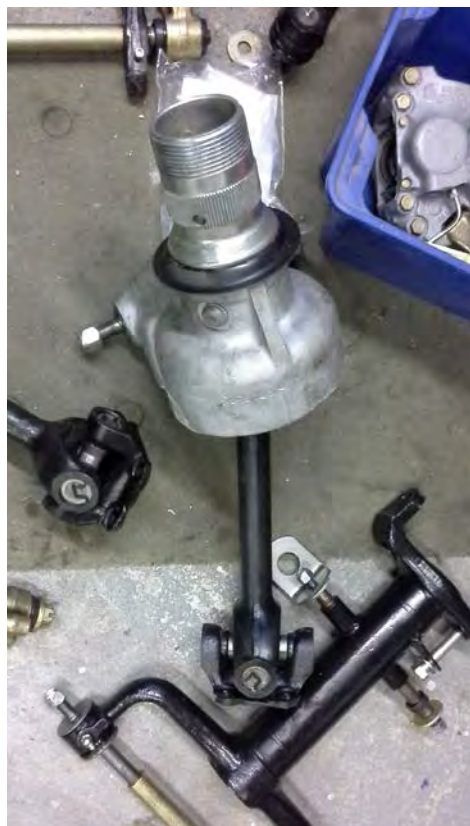
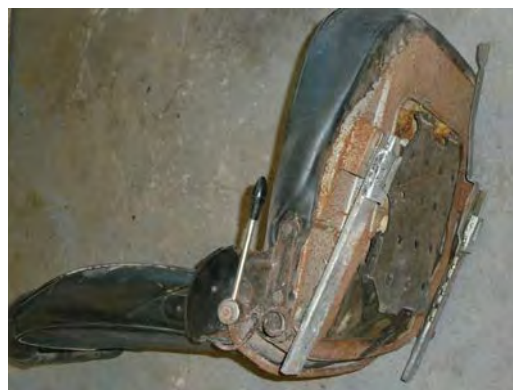
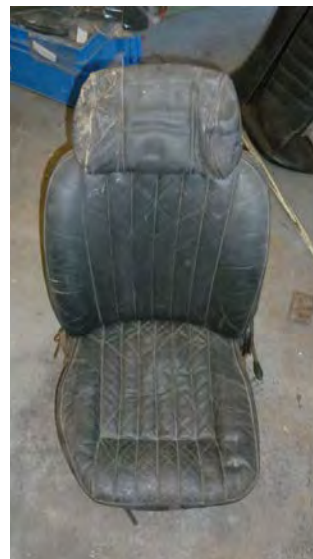
- Above left: The front upper and lower wishbone components were trial-assembled...
- Far left and left: ...along with the rear hubs and drive-shaft assemblies
- Bottom left: the rear calipers, complete with handbrake components, were reassembled using new seals and stainless-steel pistons. A replacement caliper was sourced to match the existing single E-type unit
- Below and bottom right: the front seats required substantial work. The covers were removed to reveal disintegrated foam and perished diaphragms, and the seat-base frames were rusty, as can be seen here

Both rear brake calipers were reassembled, again with new seals and stainless-steel pistons. As luck would have it, one caliper was found to be an E-type item, while the origin of the other was yet to be determined – possibly an XJ6 Series 3 or XJS. Not having previously owned an E-type,

the same. Rather than be faced with possible problems in the future, a replacement caliper was sourced to match the E-type version.

At this stage (the summer of 2015), work on the front seats had also started. The covers were removed, only to reveal disintegrated seat and headrest foams, together with what was left of the diaphragms, which I suppose considering their age was only to be expected. New covers, foams, etc, would be purchased later. The seat-base frames were somewhat rusty, as were the reclining mechanism and seat runners. These would be refurbished, and new parts obtained as necessary.

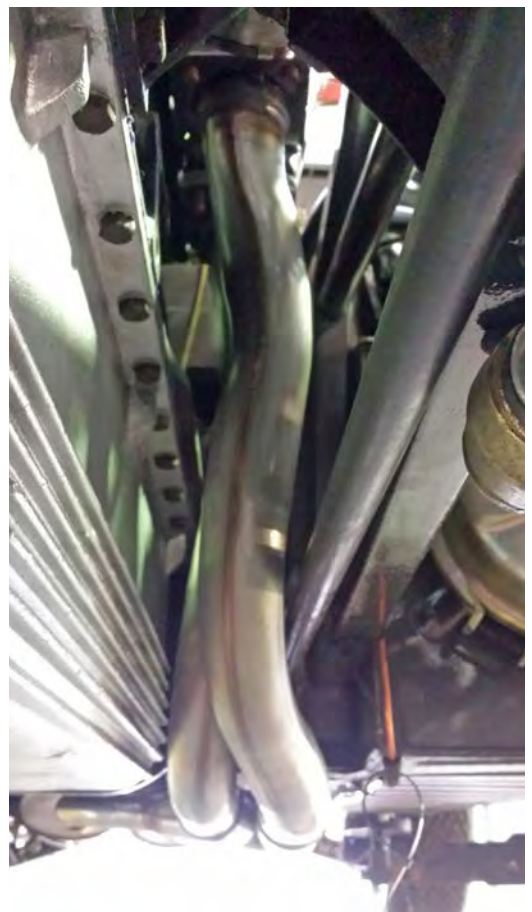
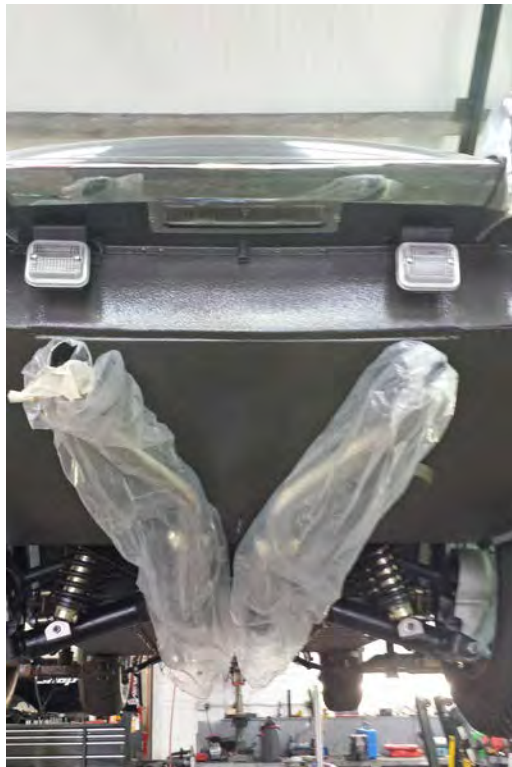
- Left: the finished result – Mike's E-type sits proudly on his drive at the conclusion of a 10-year DIY restoration project
- Below left: not a great deal of clearance between the exhaust downpipes and surrounding components, so spending time achieving correct alignment was essential
- Right: a minor problem occurred due to no mounting kit being supplied for the rear tailpipes, though this was soon resolved
- Below: taking shape: the car sits with tailpipes now safely secured and bodywork painted, but rear door yet to be fitted

The main heat shield was fitted, allowing the exhaust (a Falcon stainless-steel system) to be fitted. Unfortunately, there was no bracket or mount for the rear tailpipes, though these were still available as spares.

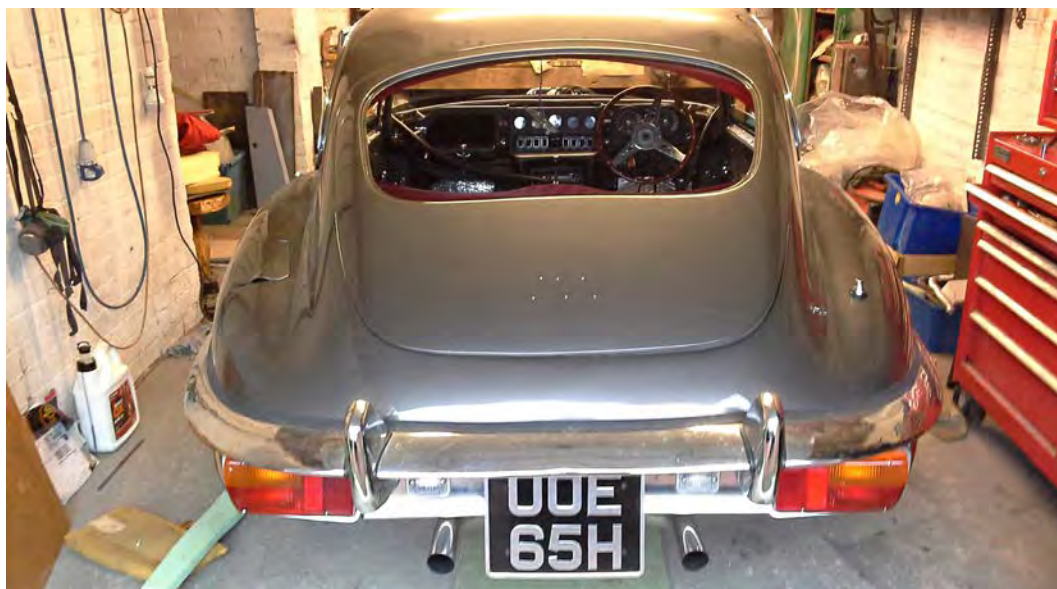
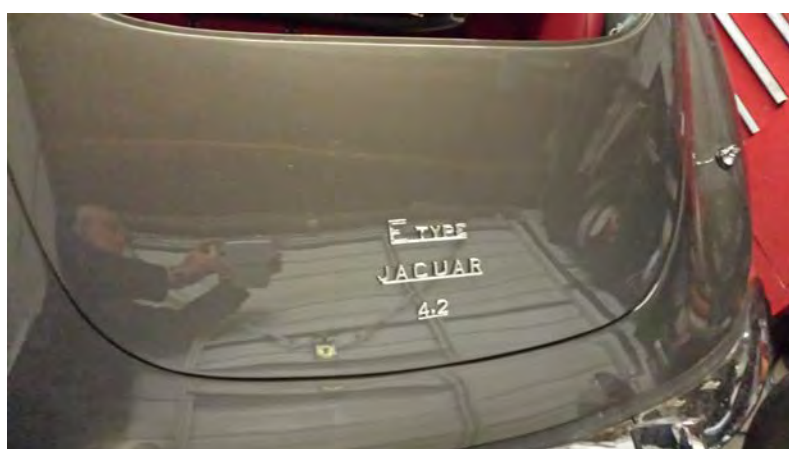
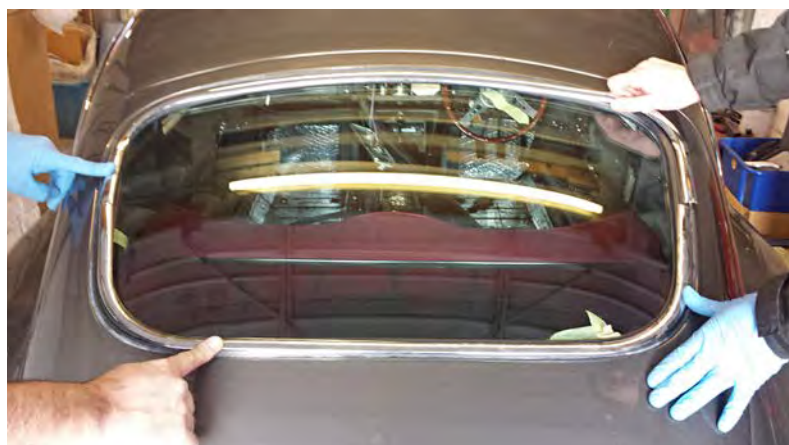
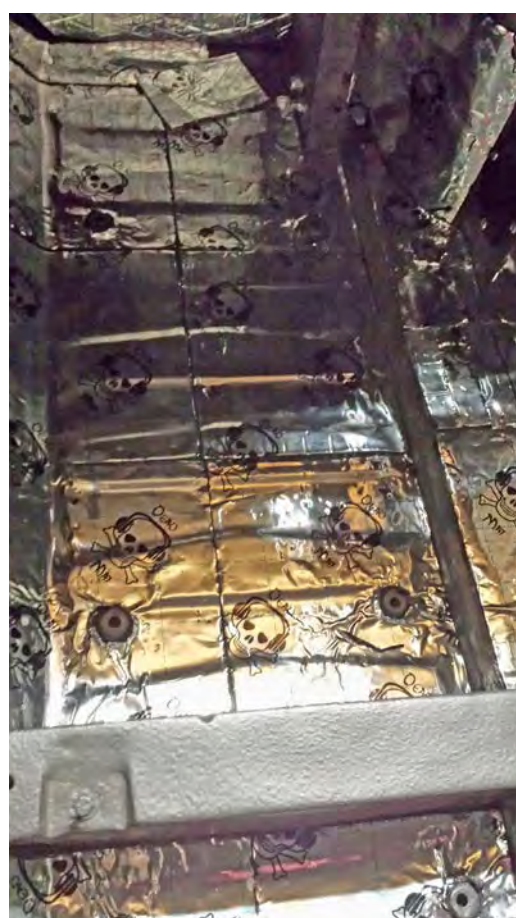
- Right: number plate and rear door now fitted
- Below left: heading towards the finishing touches with the fitting of the rear-door badges
- Bottom left: professional help was enlisted for fitting of the front and rear heated screens
- Bottom right: sound insulation fitted to the floorpan before fitting of the interior trim and seats

Because of the risk of cracking them, it was decided to entrust installation of the new front and rear heated screens to a specialist screen installer. Whilst the new front-screen bottom chrome fitted, the top one proved problematic in so much as the ends did not sit in the rubber correctly. Eventually the problems were resolved with the supplier, and new items were successfully fitted.

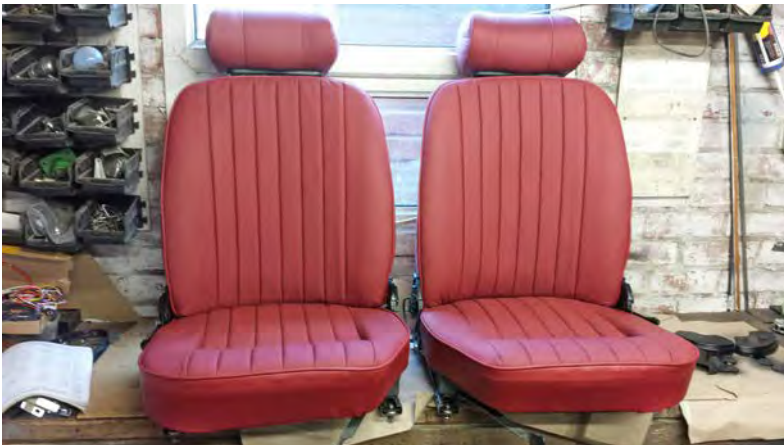
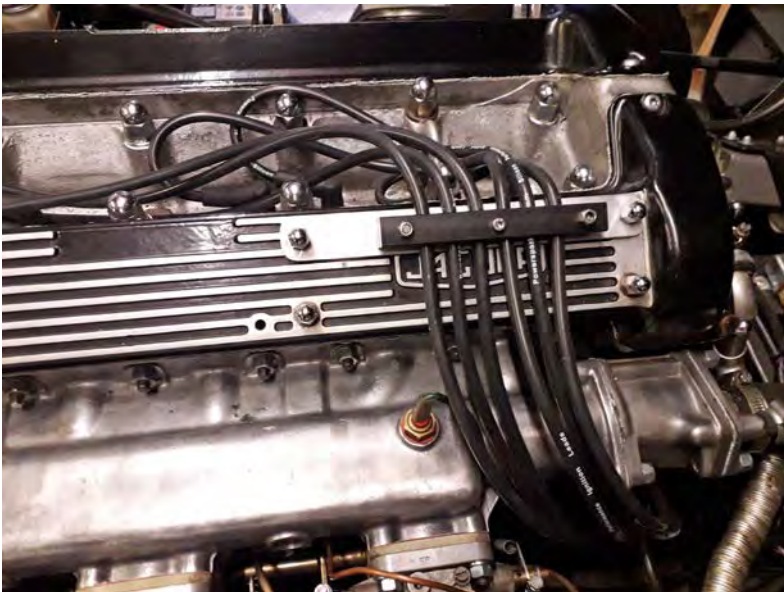
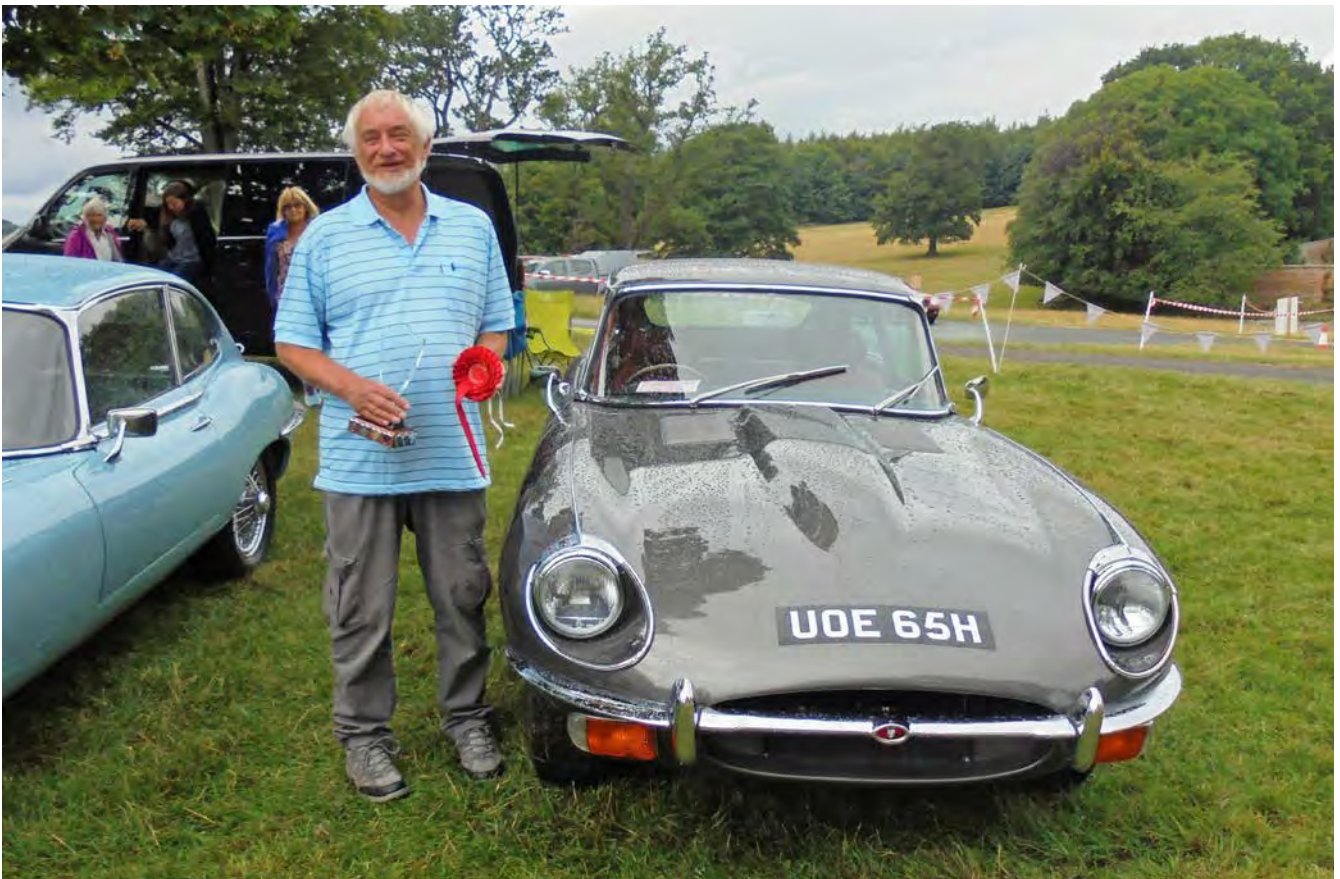
-
- Top left: the professionally leather-trimmed front seats ready for fitting
 - Left: silicon HT leads were subsequently fitted, complete with DIY lead spacer
 - Below: Mike proudly poses with the car after winning the JDC prize at Raby Castle in August 2018
