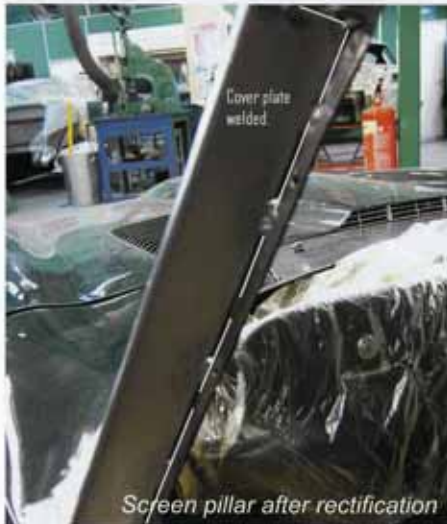
Screen pillar after rectification

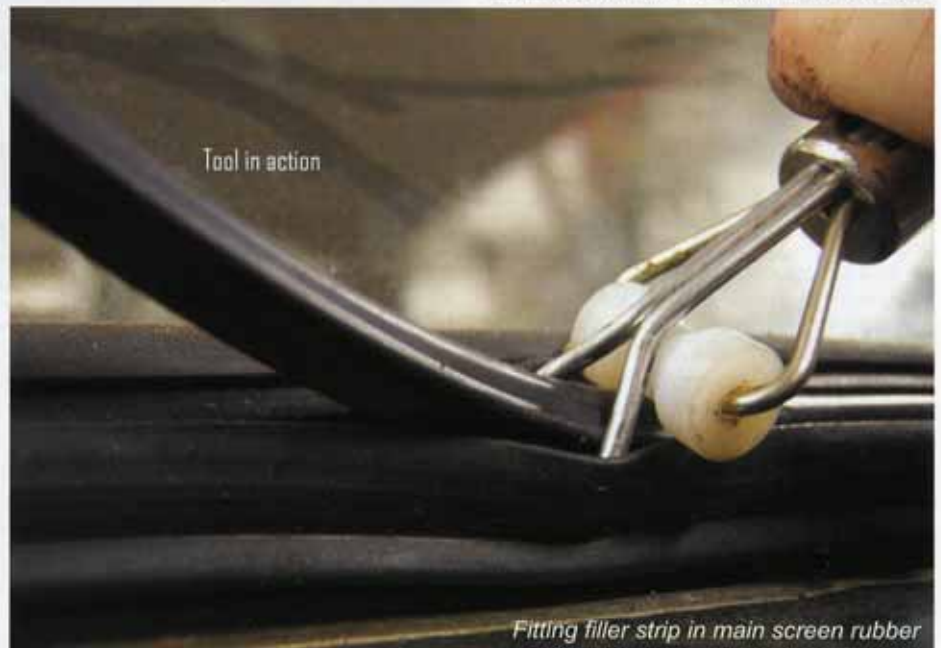
Fitting filler strip in main screen rubber

The lower main screen rubber should be
